DovBer Kahn
dov@kahnhomeinspectors.com
8445-445-8234
NY Lic# 16000053723
NJ Lic# 24GI00182100

Property Inspection Report

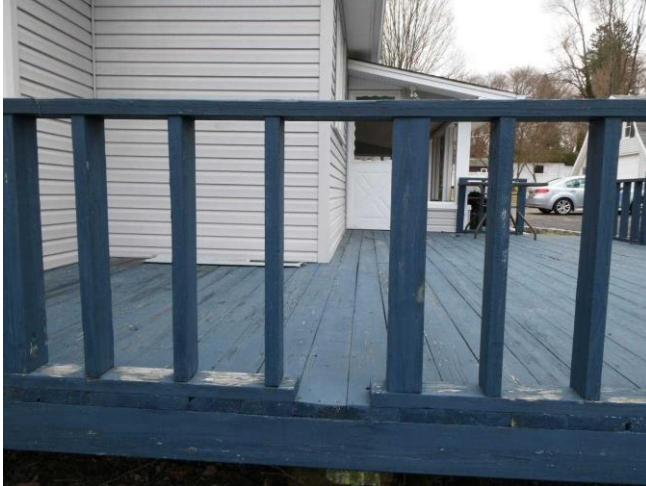
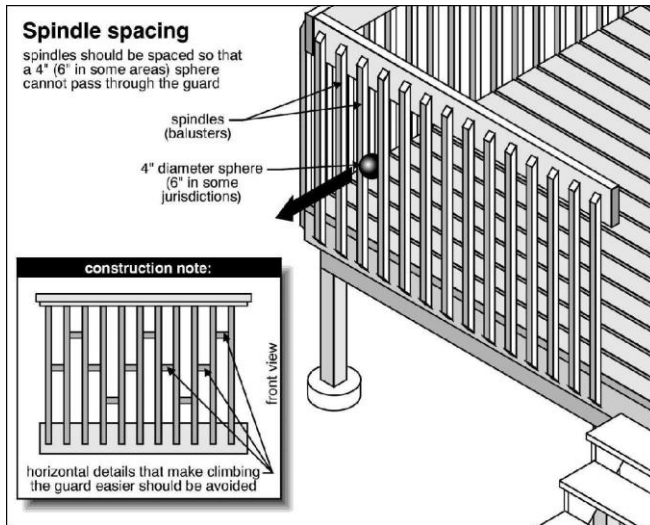
Attention Needed Rear Deck: Stained wood —

The life span for wood deck is about 15 years. Cracked and water damage to materials noted. The deck appears to be at or past its useful life. Replacement of portions of the materials should be considered.,

The spacing between balusters is greater than 4". New construction allows only 4" spacing. This was instituted as a safety issue to prevent small children from getting caught between the balusters. We recommend adding additional spindle

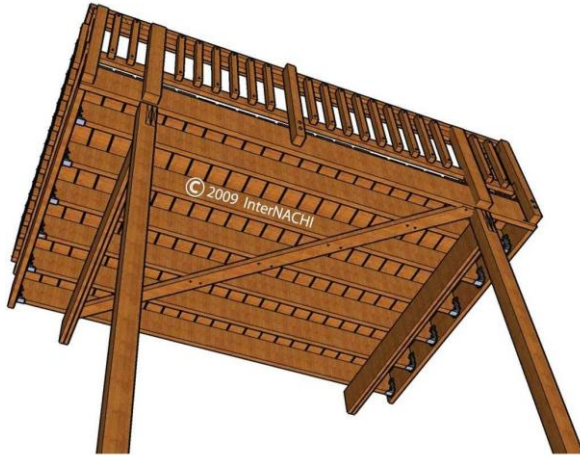
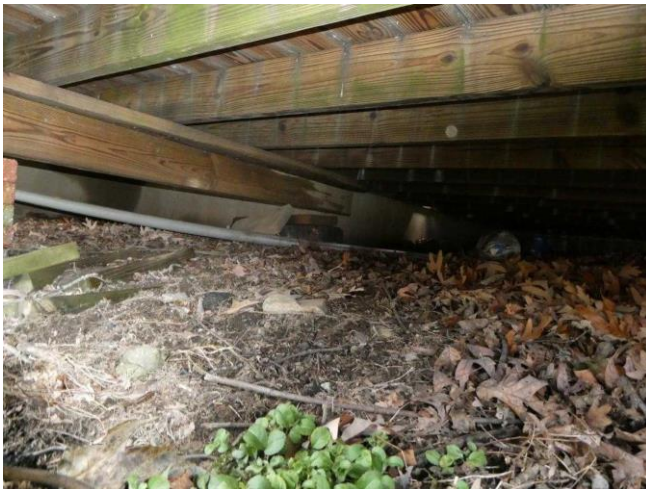
Underside Diagonal Bracing

Action Needed Rear Deck Framing: Deck framing includes creating connections between joists, beams and support columns for a deck structure.

For adequate support it is recommended to add joist hangers for support.

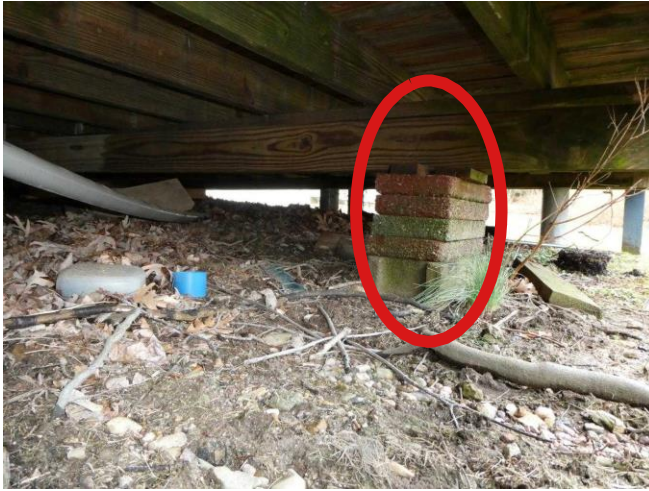
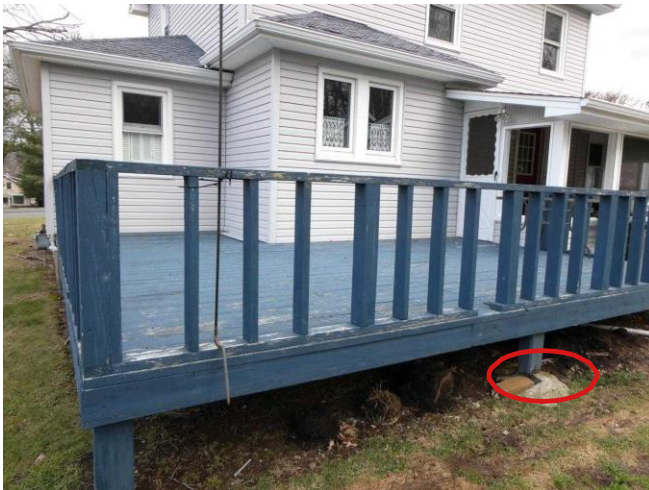
Action Needed Rear Deck Posts & Footings: Metal.

Portions of the deck girder was supported with masonry materials as posts. There is a possibility that portions could become dislodged and result in deck support failure. Repairs by a reputable licensed decking contractor is advisable.

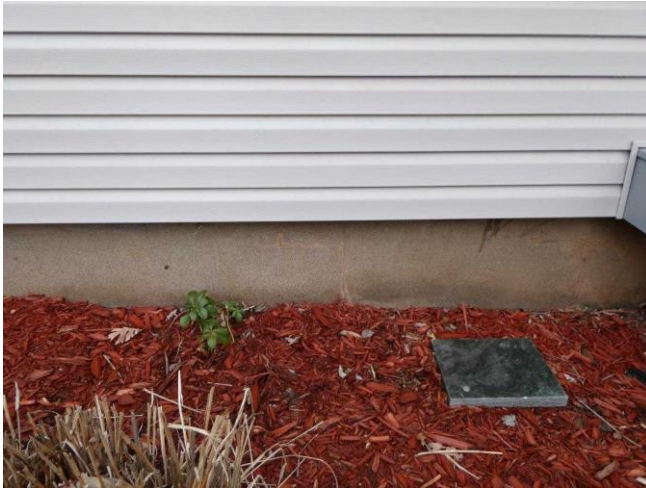
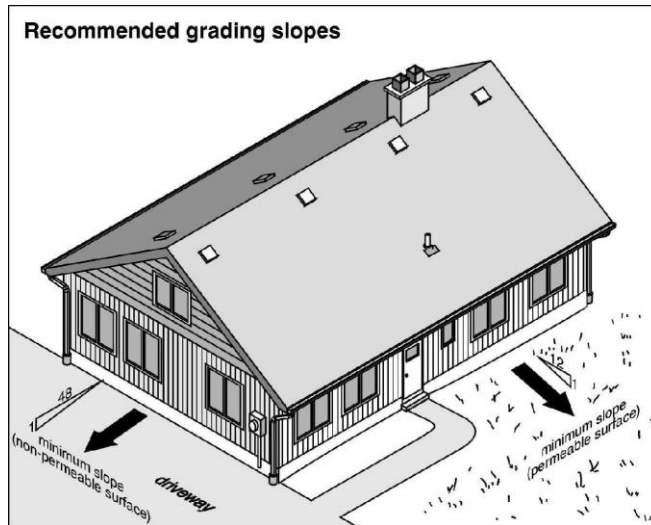
Improper soil slope towards foundation at front and right. It's recommended the services of a professional landscaper to addition fill dirt and improve grade.

There was wood mulch up against the house/ garage foundation and near the framing. It is recommended to keep a 6" gap of bare ground or gravel between wood mulch and the house foundation to reduce the risk of termites. The wood mulch should be replaced with gravel.

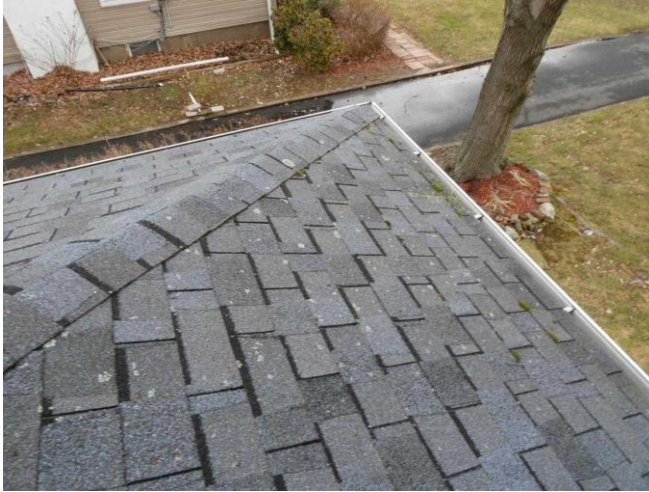
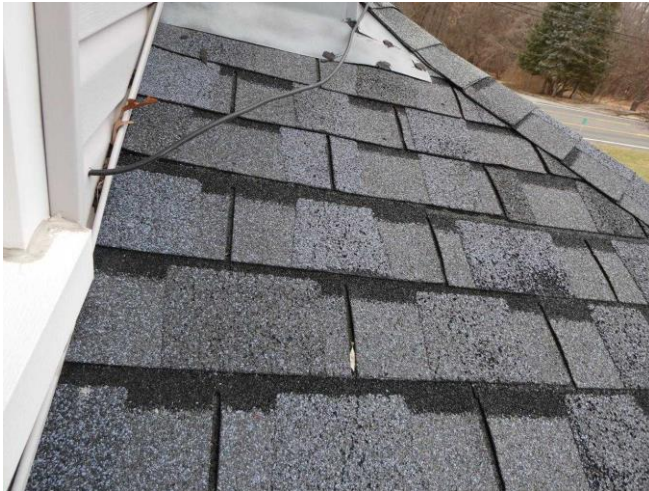
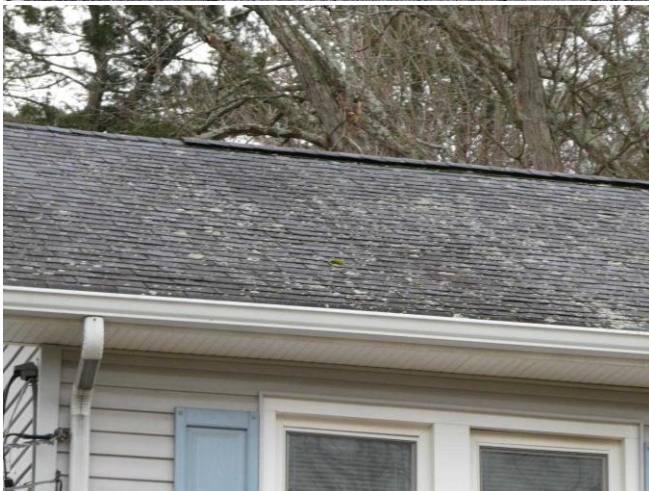
The lower roofs - Black stains at the top of the shingle tab should be covered by the course of the shingles above. This condition is indicative that the roofer tried to stretch his supply of shingles by not overlapping the shingles as designed, which weakens the whole system. ,

There is some granular loss. This is a warning that the shingles are not protected from the ultraviolet rays that cause deterioration to the asphalt matt.,

The Roof Covering Has Several Areas of Algae / Moss Substance. The presence or absence of much sunlight on a roof surface is often a determining factor in the amount of moss or algae growth (more sun, less moss and algae). When shade and cool moist conditions combine, moss or algae growth on a roof surface is more likely. Algae / moss are typically more than a cosmetic issue on asphalt shingles. By holding moisture against the roof surface moss or algae speed the wear of the asphalt shingle surface in freezing climates by increasing frost damage to the mineral granule coating on the shingles.

Lichens: There was much greenish substance on the on roof covering which appears to be from Lichens. Lichens are an admirably tough symbiotic organism made up of typically algae and a fungus. The lichens can retain water against the roof and cause damage to the roof. Professional / certified cleaning is advisable.

Repairs are recommended.

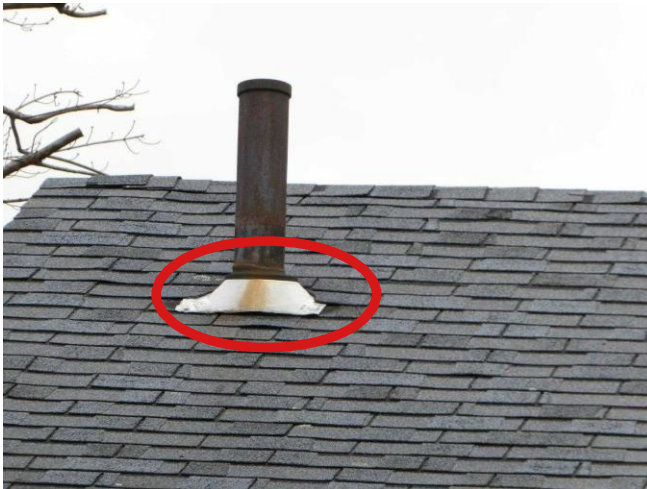
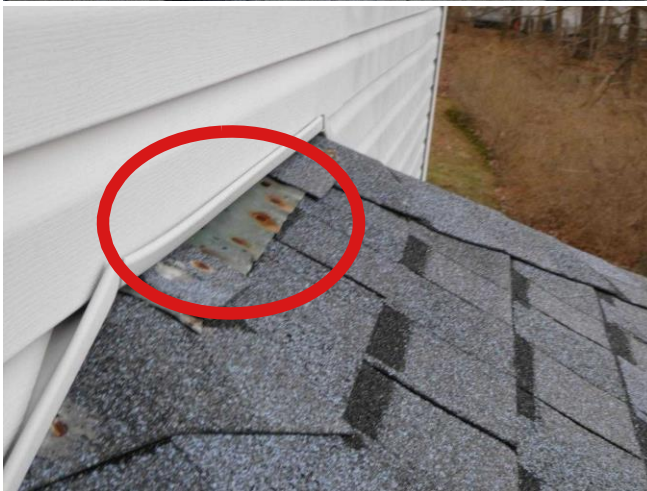
At least one of the rear plumbing vent flashing were coming up. This condition makes the area prone to water leakage - repairs are recommended by a reputable roofer.

Left roof to wall flashing had some rust and did not appear flush - repairs are recommended by a reputable roofer.

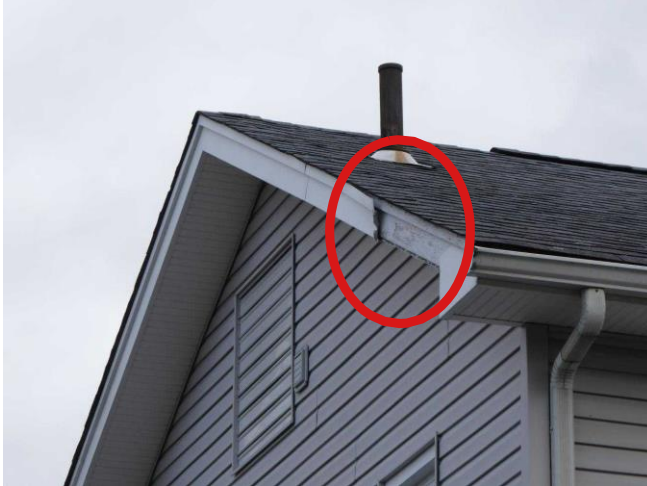
Minor Rake Board: Rake boards are the vertical piece of the sloped end of a roofs overhang. They help create and define the angle and slope of the end wall of a gable. The right siding at rake board was missing - repairs are recommended.

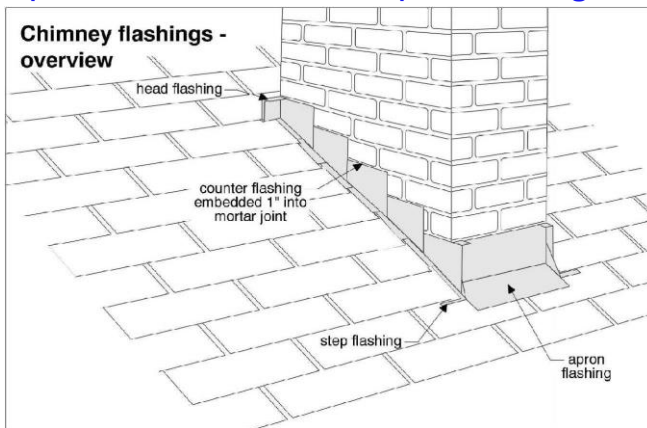
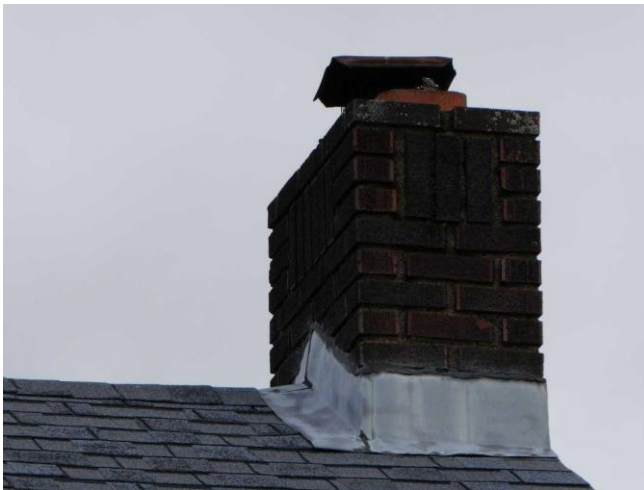
Tar patching was noted at chimney flashing areas. Tar sealant is inadequate and prone to leakage. Repairs and further evaluation by a reputable roofer is advisable., ,

Improper installation- counter flashing is not recessed into mortar joints- requires corrections by a reputable mason contractor to prevent leakage.

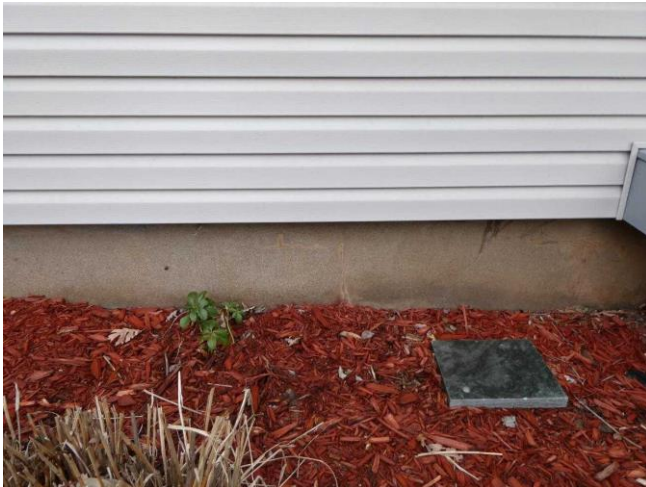
Foundation: Basement Structure —

There were hairline cracks noted at the front exterior wall. There was step cracking at the interior foundation (common) wall to crawlspace.

The current condition appears not to be a structural concern. Seal the cracks with a non-hardening type caulking material and monitor over a full-year period. If any further movement occurs, contact this company or a structural engineer. Taking photographs will be helpful when monitoring the cracks for possible changes. Include a measuring tape in the photographs, position the tape next to and across the crack. This will help to document the width, length and shape of the crack.

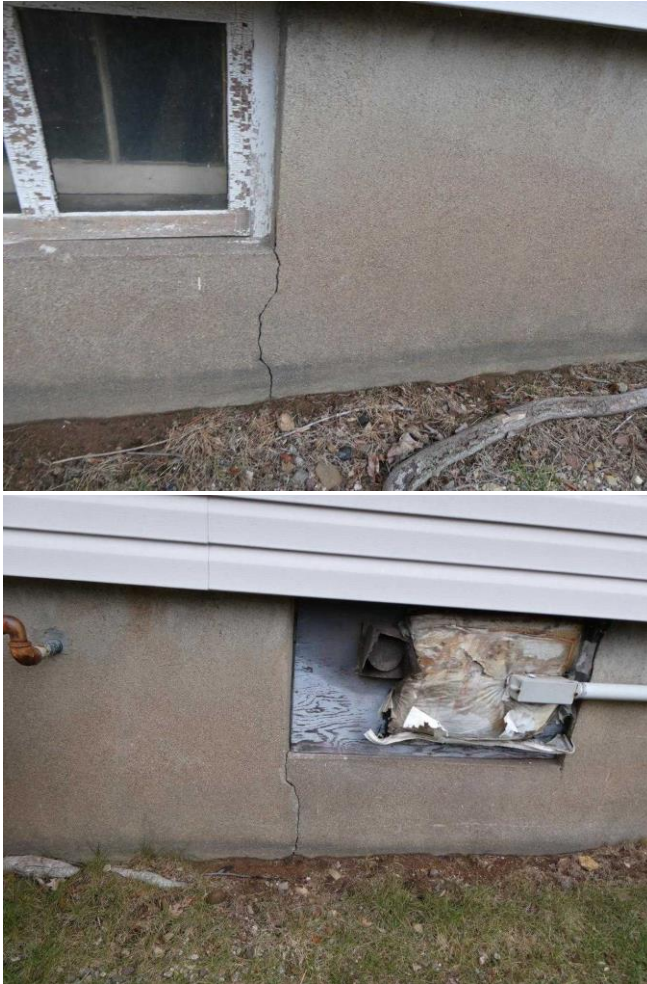
Attention Needed Foundation: Crawlspace —

There was vertical cracking with displacement at the right exterior crawlspace foundation wall. The corresponding interior was not visible. A structural engineer is recommended to evaluate and estimate repairs

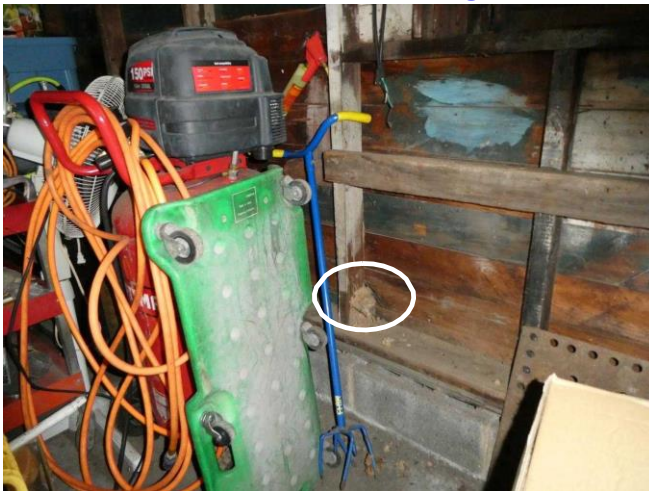
There was suspect substance and damage at the rear garage wall that appears to be from WDI (wood destroying insects). , Further Invasive inspection by a reputable exterminator is recommended to determine the extent of the damage and whether treatment is advisable.

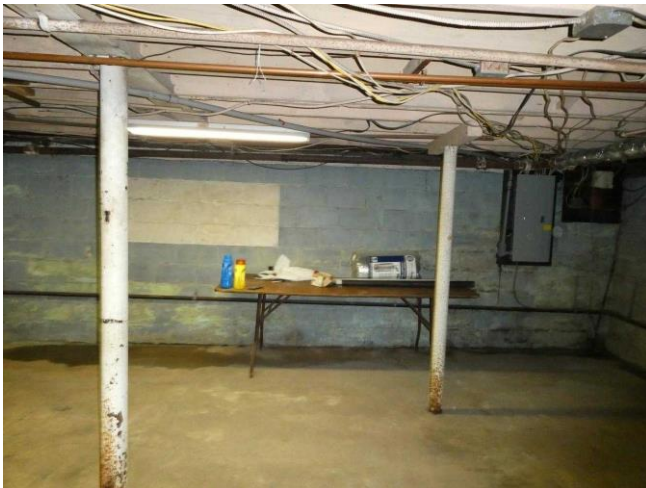
Attention Needed Moisture Location: Front of the basement.

Excessive water entry provides a conducive environment for mold growth, wood destroying insects and may affect the foundation support.

- 1) Wet stains at floor of basement adjacent to front foundation wall.
- 2) Rust at bottom of metal supporting columns.
- 3) water stains foundation walls.

Repair exterior grade - please refer to lots and ground section of the report for details.

After performing the steps above, monitor the foundation areas over a period of a full year. If there are still signs of water intrusion into the crawlspace then the services of a reputable licensed foundation contractor to perform water proofing is recommended. For additional information please refer to the ASHI manual, heading - Wet Basements.

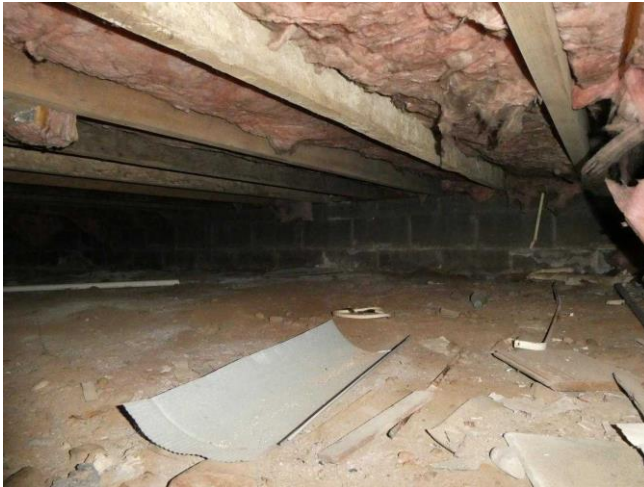
Attention Needed Moisture Penetration:

There was sagging insulation which is a sign of moisture / water entry. The insulation acts like a towel, absorbs the moisture and sags.,

Efflorescence (efflorescence, a crystalline mineral salt left behind as moisture comes through the wall and evaporates into the building interior) was noted on portions of the walls.

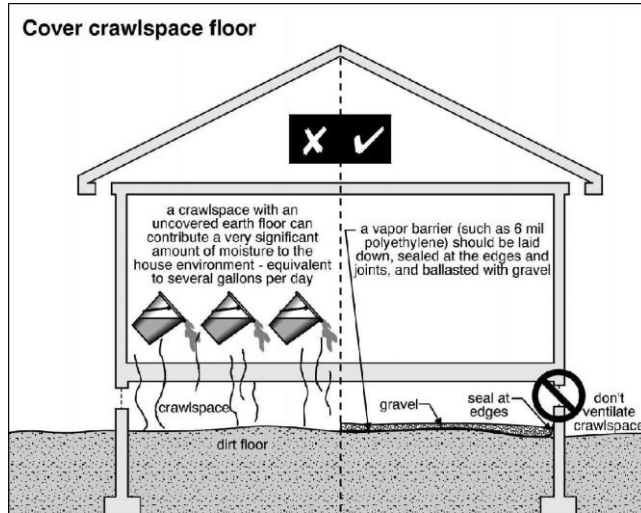
Attention Needed Moisture Barrier:

No moisture or vapor barrier present. This condition allows for moisture to enter the living areas which can cause rot and possible mold. A vapor barrier should be installed.

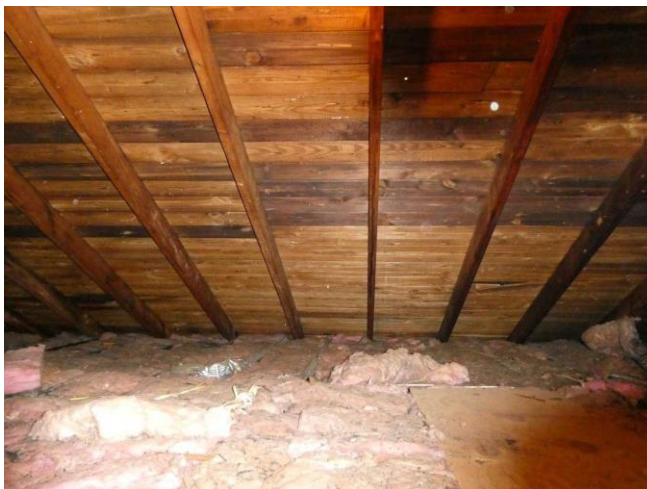
Attention Needed Roof Framing: 2"x 6" Rafter —

Portions of the roof framing had 2" X 6" rafters which is substandard. A qualified roofer should further evaluate the framing prior to closing.,

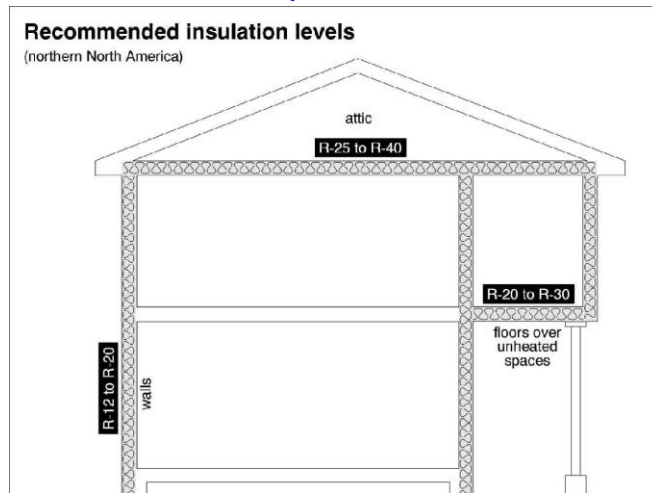
Attention Needed Insulation: Fiberglass —

Insufficient insulation present, It is recommended that additional insulation be installed.

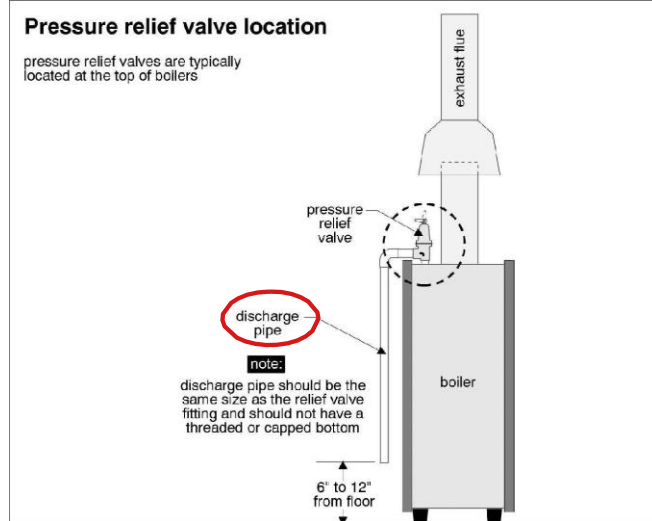
Attention Needed PRTV Tube:

There was no PRTV discharge tube installed. Lack of discharge pipe could allow water to discharge in a manner that could cause scalding. A discharge pipe should be installed.

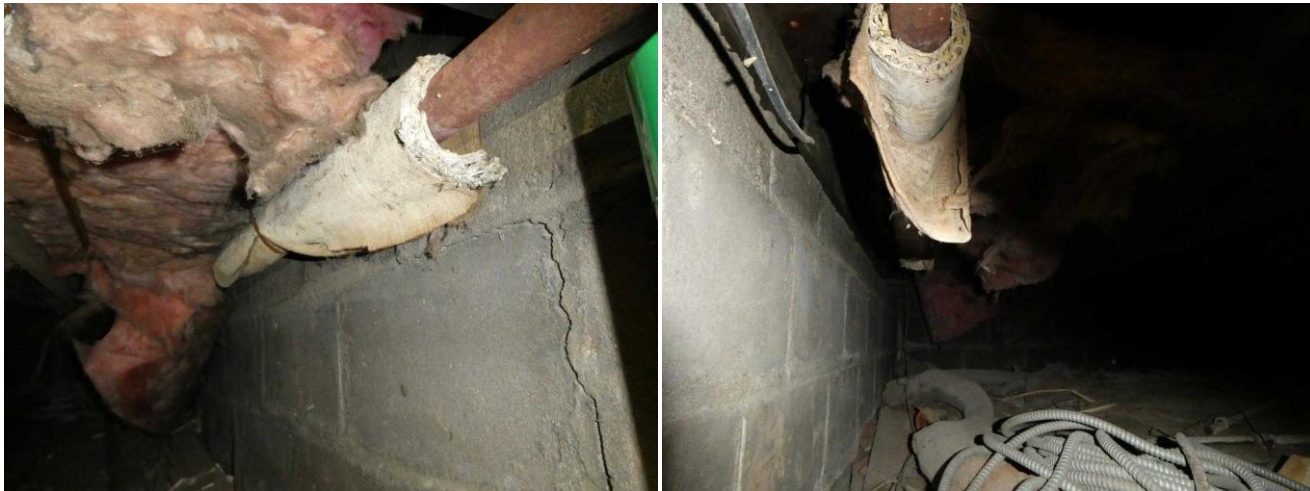
Suspected Asbestos: Yes —

Friable asbestos materials were noted at basement / crawlspace area. Removal / encapsulation by a licensed asbestos contractor is recommended.

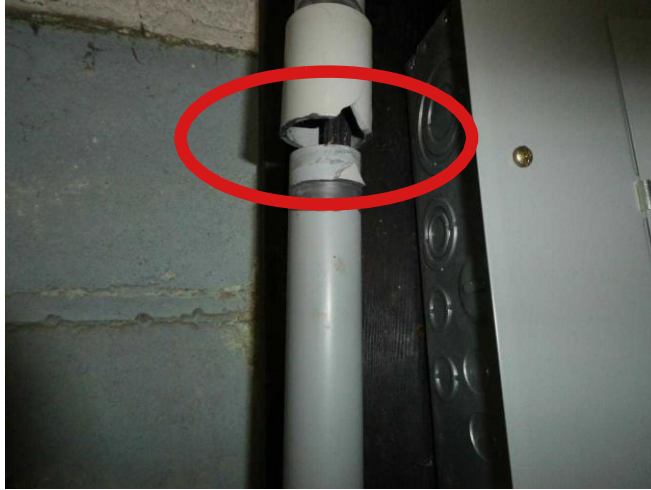
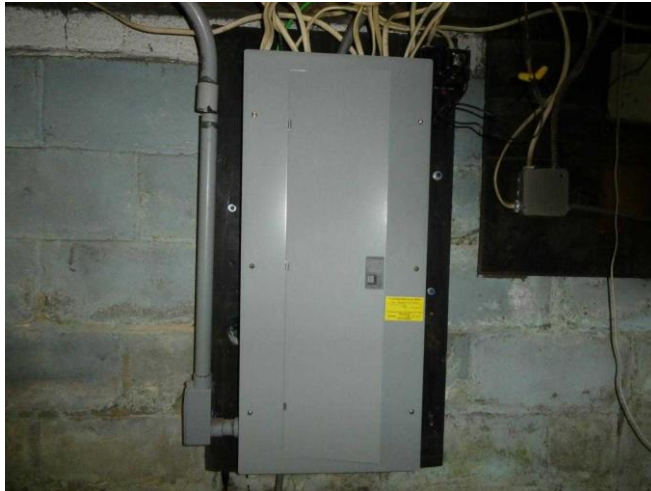
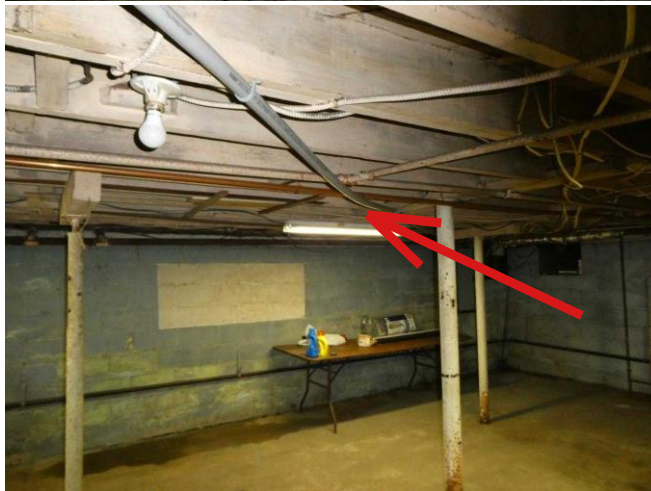
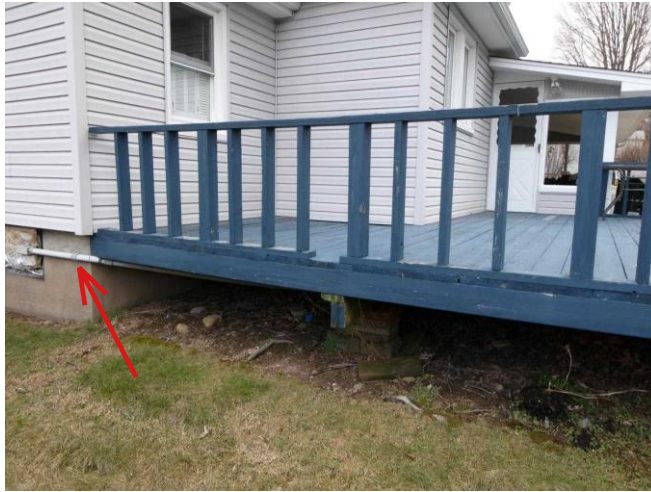
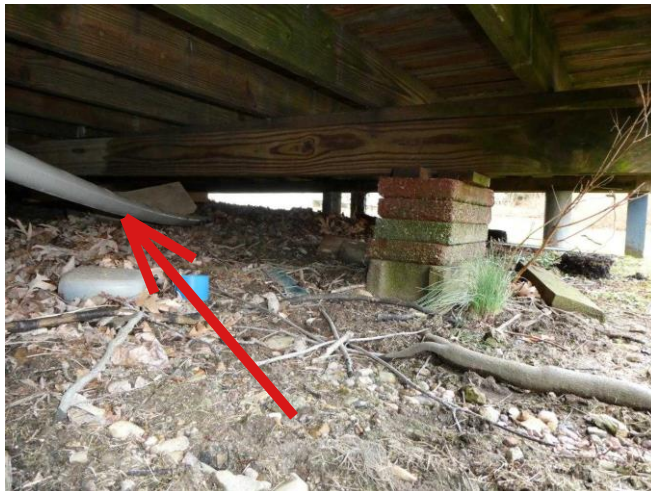
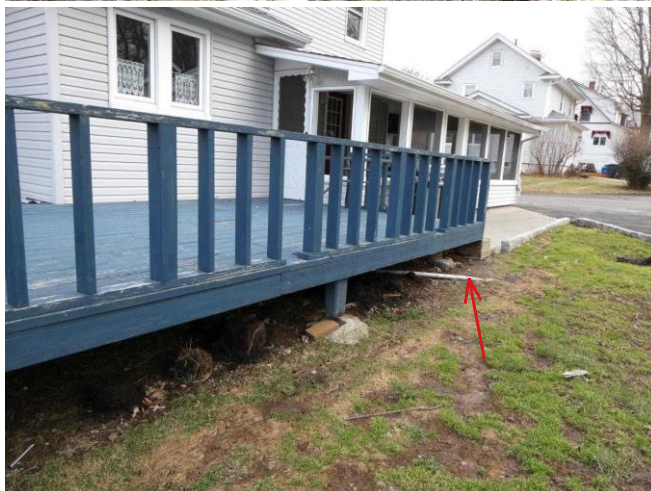
C) Improper electrical conduit installation including open joints.

Not properly supported run suspended partly in air, and not buried safely out of the way of mechanical damage - e.g. by a lawn mower

The original portions of the home was built in 1920's and has since undergone renovations. Further invasive inspection by a reputable licensed electrician is recommended.

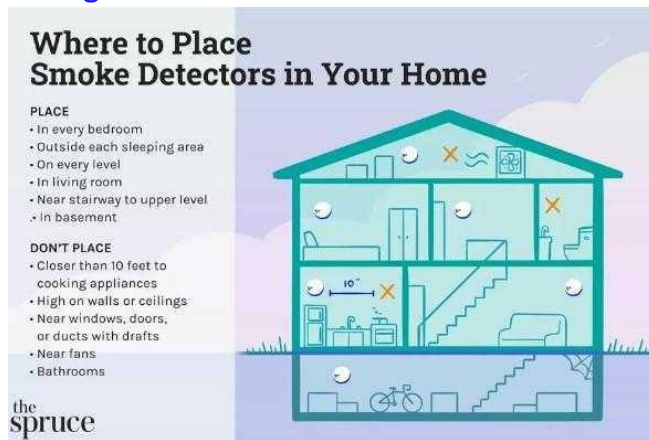
Attention Needed Smoke Detectors: Smoke detectors are recommended to be installed in each bedroom and adjoining hallway and each living level of the home and basement level. **Portions of bedrooms were lacking smoke detectors. Smoke detectors should be installed.**

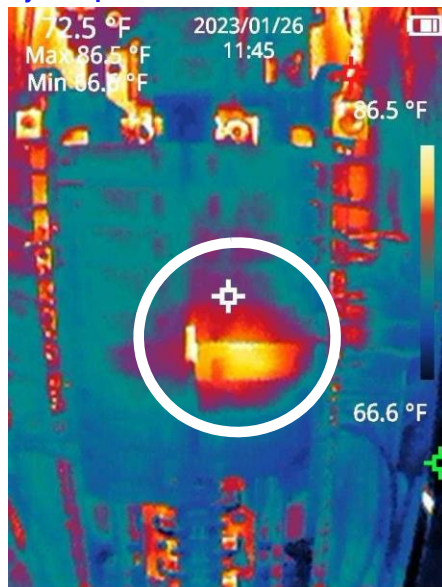
Attention Needed Manufacturer: General Electric —

The electrical panel was tested for overheating. A Portion(s) of the breaker were hotter than other breakers. This condition is indicative that several of the breakers are overheating. Further evaluation by a reputable licensed electrician is needed.

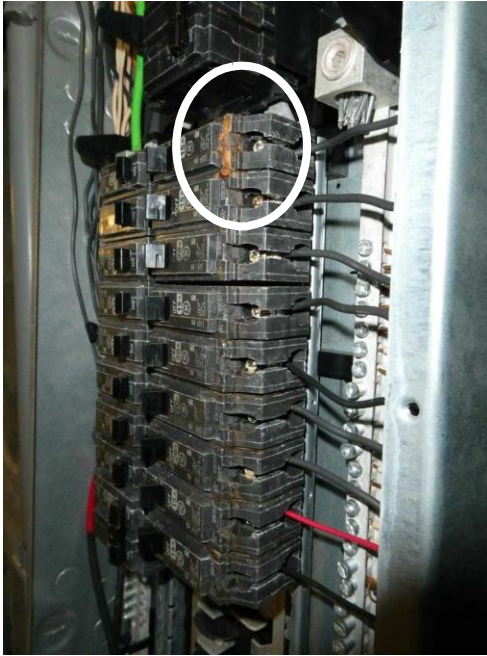
Attention Needed Breakers: Copper —

[Corrosion on breakers from water penetration-require replacement of affected breakers](#)

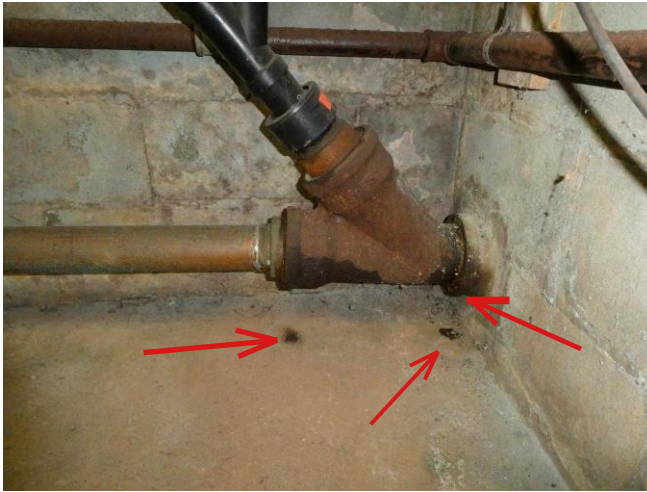
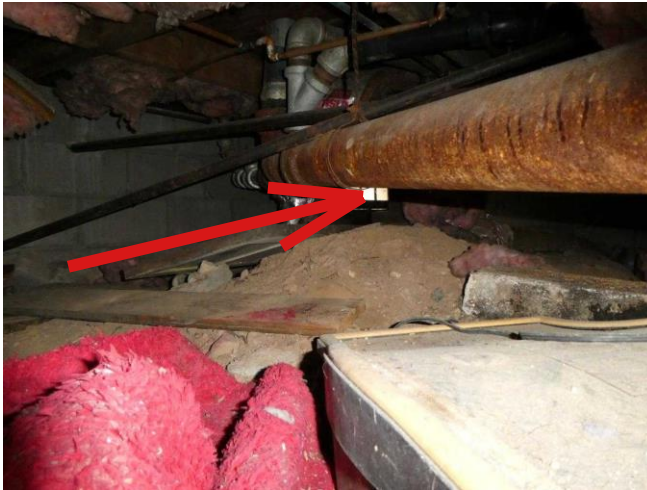
Cast Iron was popularly used in home prior to 1950's. The life expectancy of cast iron materials is about 50 years. Replacement to at least part of the materials should be anticipated.,

Evidence of leakage as noted by the stains beneath area where sewage piping penetrates foundation wall.

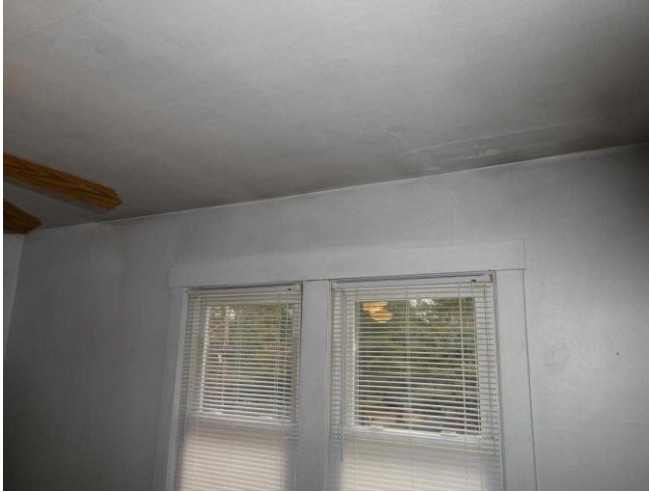
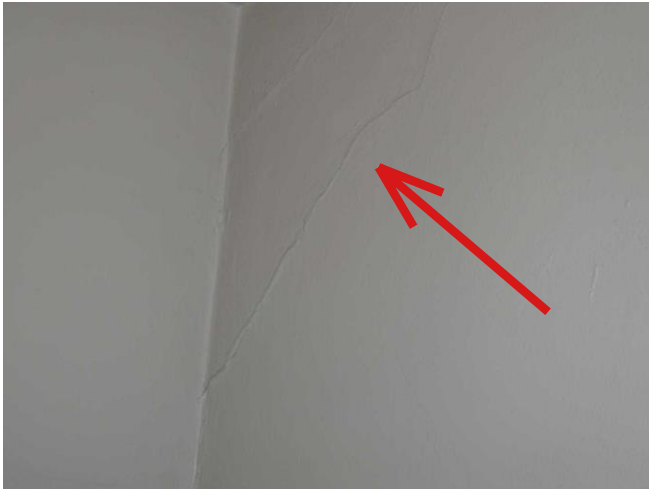
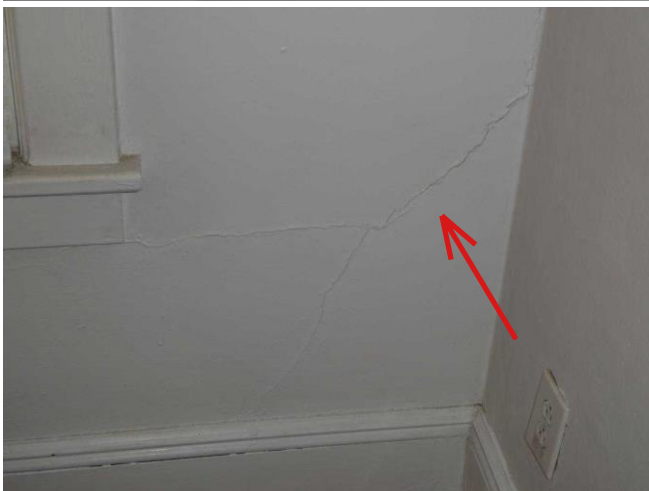
There was thermal bridging / ghosting noted at the front left bedroom ceiling. Ghosting is a condition that dark stains appear on the studs / framing of the homing due to lack of thermal / heat loss or inadequate air movement through the home.,

Cracks present at portions of the walls at upper level. The cracks appear typical for the age of the home. Monitor area for displacement.

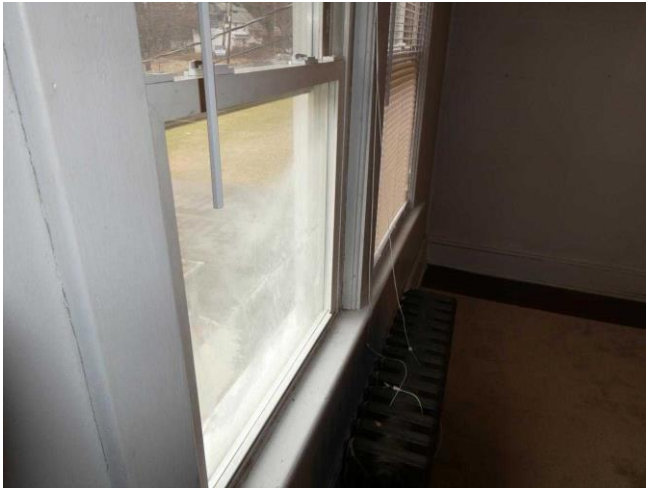
Front left upper level windows insulated glass windows have lost their vacuum seal. As a result of losing this seal, condensation between the two panes creates a clouded or streaked appearance. The window still performs the task of keeping the weather out, but it has lost much efficiency.

The window slam shut at main floor rear bedroom window - repairs are recommended.

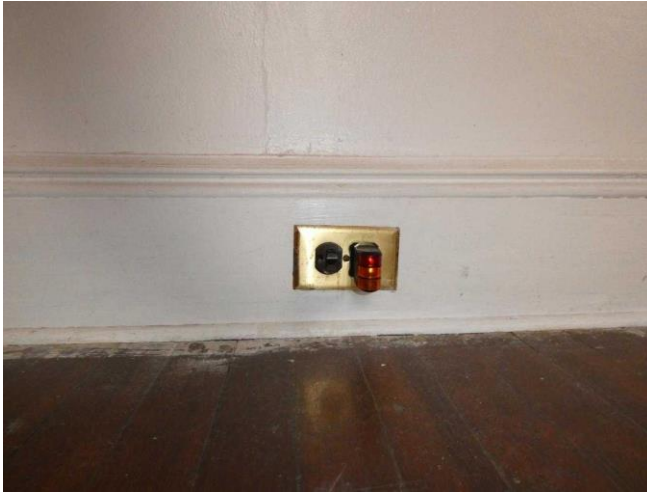
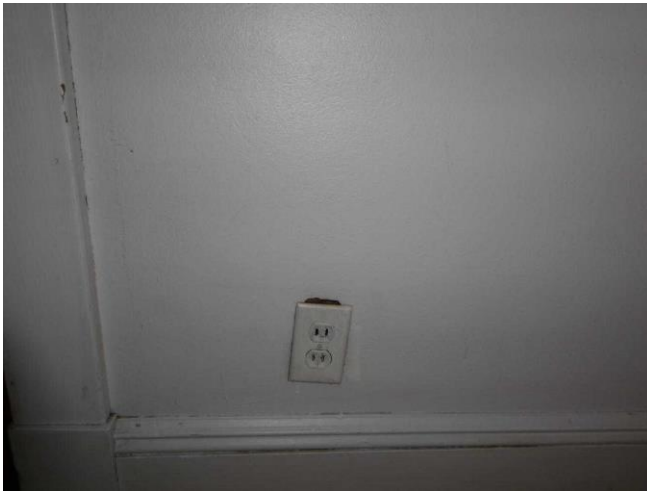
Attention Needed Electrical: 110 VAC —

Open or missing ground, 2 prong outlets were noted.

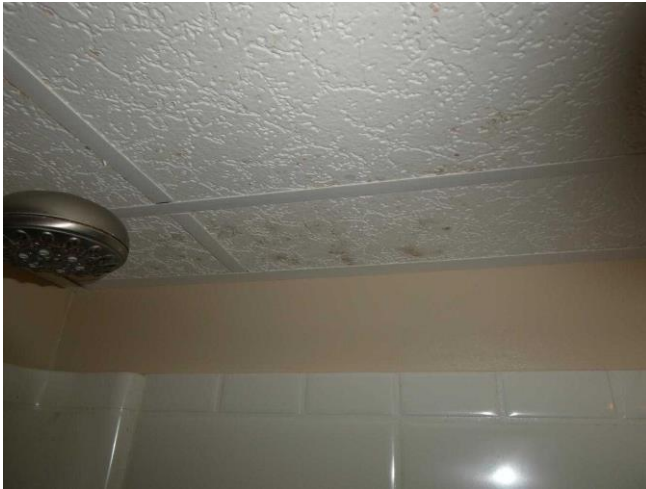
Attention Needed Ceiling: Paint and Tiles —

Blackish substance noted at main floor ceiling tiles above shower. Professional cleaning is advisable. Mechanical ventilation (fan) should be installed to enhance proper ventilation.

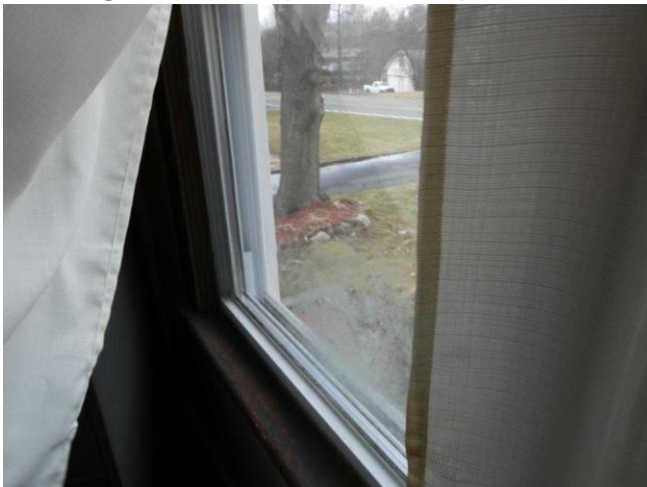
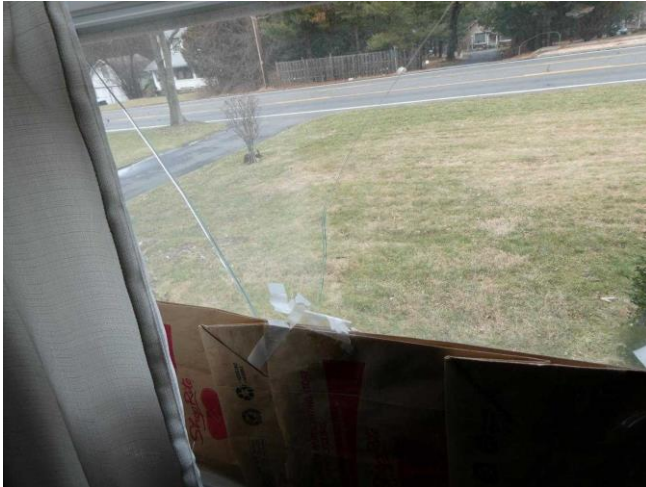
Insulation Seal - One or more insulated glass windows have lost their vacuum seal. As a result of losing this seal, condensation between the two panes creates a clouded or streaked appearance. The window still performs the task of keeping the weather out, but it has lost much efficiency.,

Broken glass pane - replacement of pane is needed.

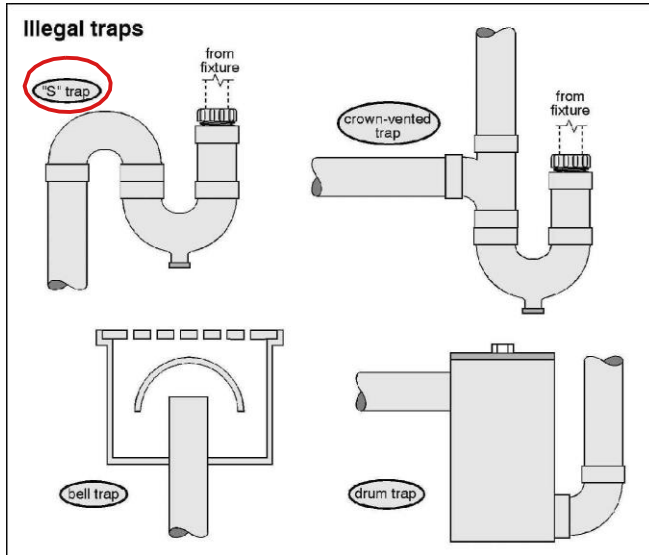
Sink: Stainless Steel —

The installed trap is not an approved P-trap, or it is installed in an unacceptable manner. Improper trap can allow sewage gasses to enter the home. Services of a reputable licensed plumber is advisable.
