Property Inspection Report

Inspection Date: 08/16/2022

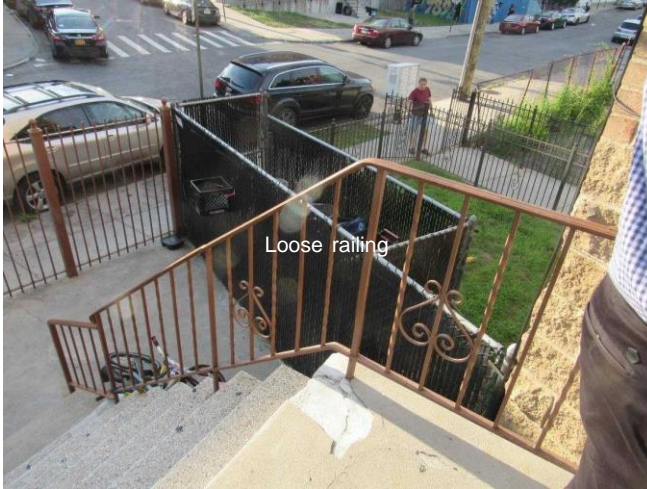
Attention Needed Steps/Stoops: Concrete materials.

Loose railings. The railing can not adequately support the weight of an adult.

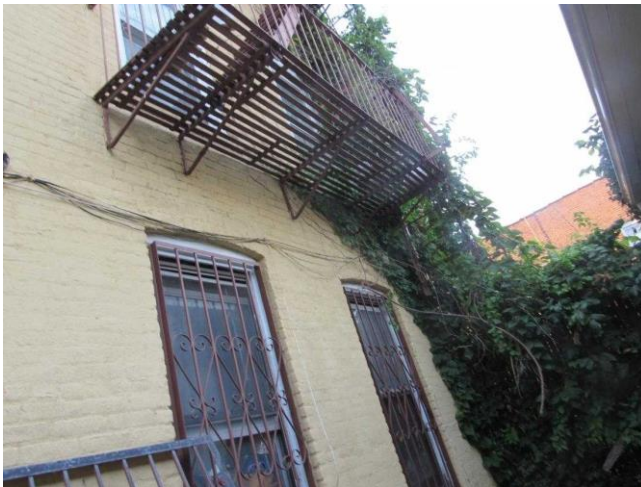
Attention Needed Vegetation: Ivy —

There was ivy crawling up the rear of the building. The ivy will damage the siding and structure and should be removed.

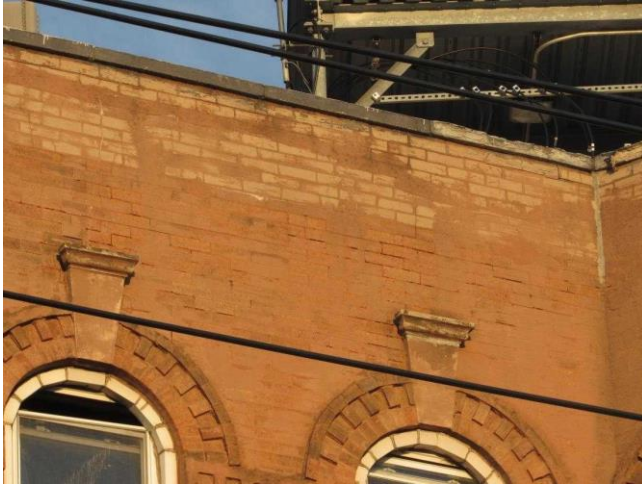
Type: Brick Structure — Portions of the front upper bricks were repaired. There was no apparent damage. Areas should be monitored for settlement and repaired as needed.

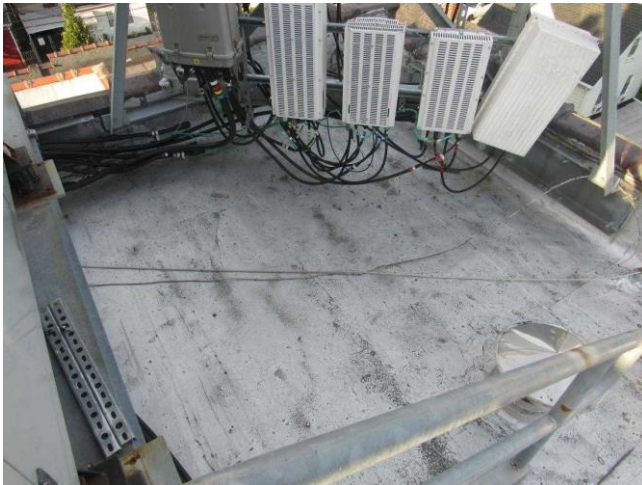
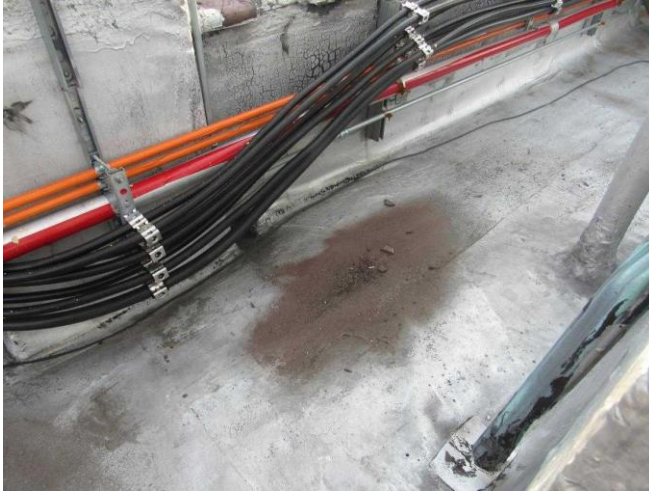
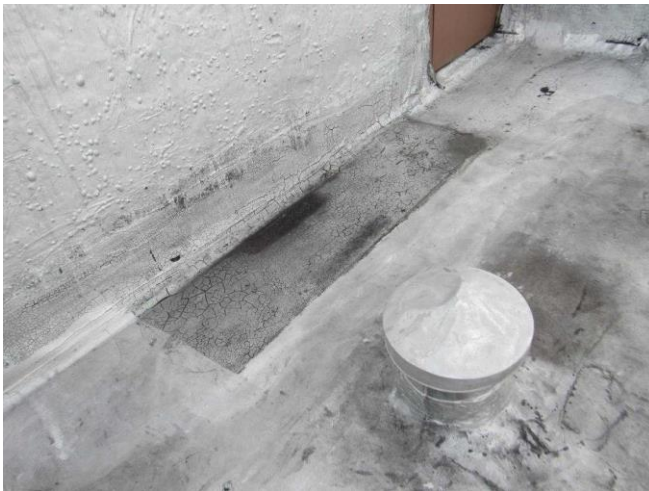
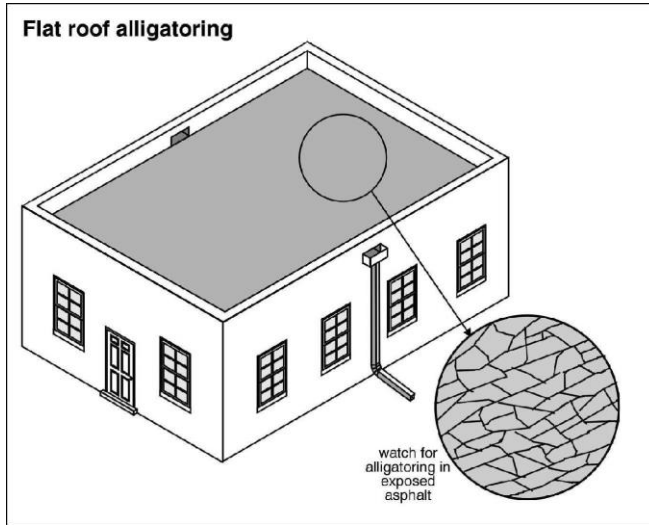
Roof at end of useful life. Following conditions were noted:

(A) Alligatoring / checking of the roofing materials. - Alligatoring is the term used to describe a flat roof condition that appears similar to the hide of an alligator. The cracks intensify, allowing moisture to enter the roofing system. The moisture can travel throughout a flat roof, which can cause leaks that are located far away from the actual source of entry. Repairs and further evaluation by a licensed roofer is recommended,

(B) Black stains noted at several portions of the roof covering. The staining is indicative of water damage. Portions of APT #9 ceiling was damaged, per tenant water does seep through after heavy rains. Continuous damage may cause leakage.

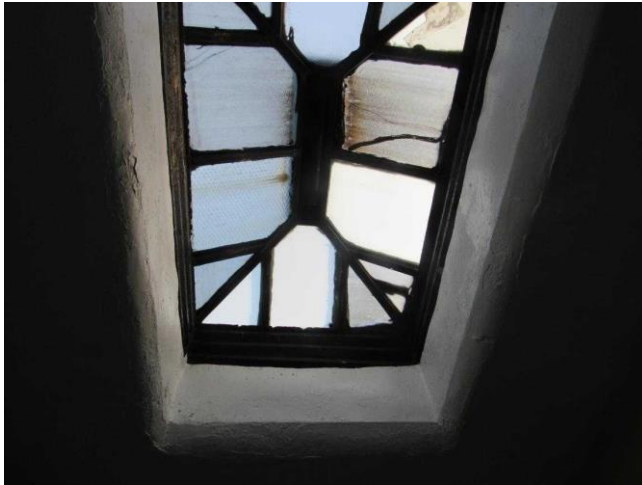
Skylights: A curb mounted skylight is attached to the roof with a wooden frame. Evidence of past water leakage. Cracked portions of glass.

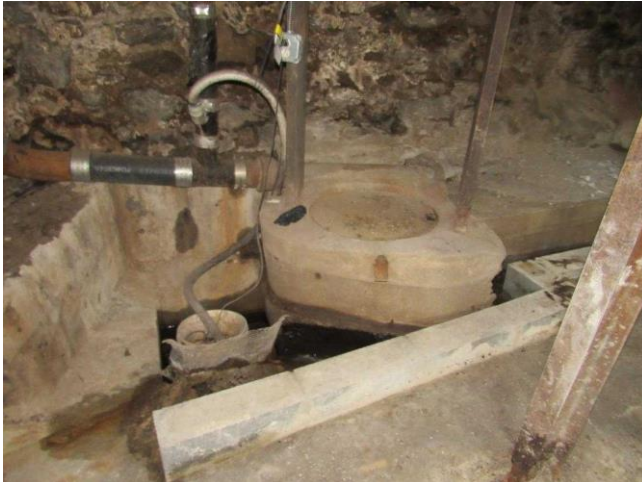
Attention Needed Moisture Location: Excessive water was noted in drain —

Excessive water entry provides a conducive environment for mold growth, wood destroying insects and may affect the foundation support.

We recommend:

- a) Repairs to the gutter drainage system. Please refer to roof section for details.
- b) Repair basement drainage system.
- d) Monitor area for water intrusion.

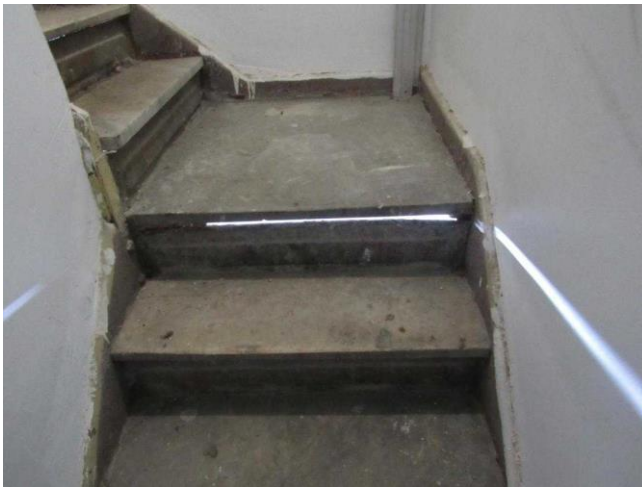
Attention Needed Basement Stairs/Railings: Metal stairs —

There was no stair railing - Railings provide stability, which is especially important for young children, the elderly, and people with disabilities. A railing should be installed.

Light was entering portions of the staircase which is indicative that area is not well sealed - repairs are recommended.

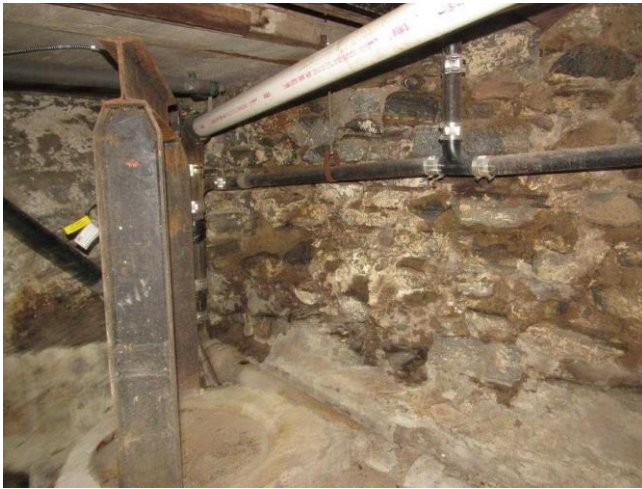
Attention Needed Foundation: Stone - Masonry walls. Stone with masonry joints were common in homes built before 1950.

The foundation walls were missing much mortar in between the stones. Lack of mortar can allow water to enter the structure - causing mold growth and foundation damage that may weaken the integrity of the entire wall and structure. Services of a reputable mason / foundation contractor is recommended.

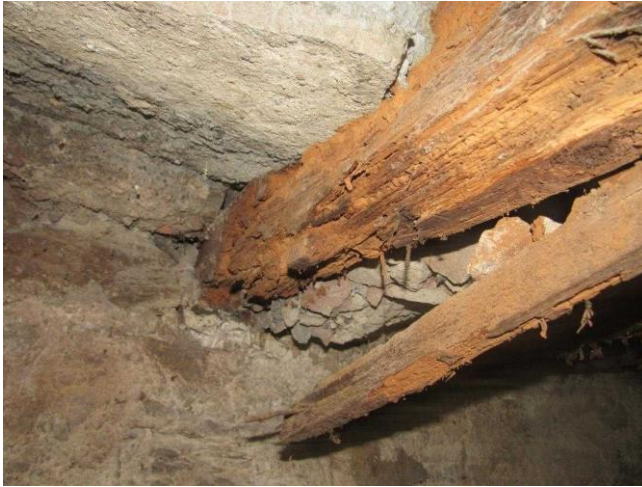
Portions of the joists had excessive wood destroying insect damage.

Services of a reputable licensed exterminator is needed to treat the entire structure for WDI. All damaged wood should be replaced by a reputable contractor.

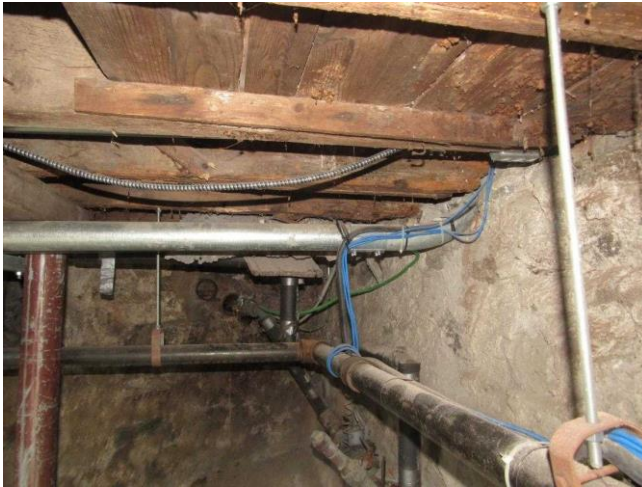
**Action Needed****Joists/Trusses: Wood —**

Many of the joists support have been compromised due to WDI and possible water damage. Additional sister joists should be installed. Consult with reputable licensed structural engineer or licensed framer as to the exact specifications and costs involved.

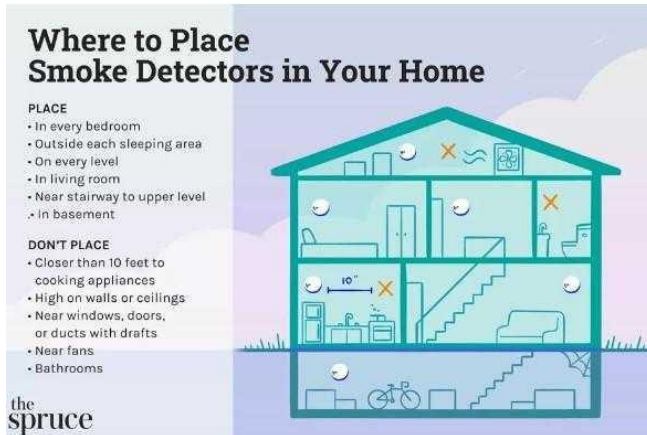
Attention Needed Smoke Detectors: Smoke detectors are recommended to be installed in each bedroom and adjoining hallway and each living level of the home and basement level. **Portions of bedrooms were lacking smoke detectors. Smoke detectors should be installed.**

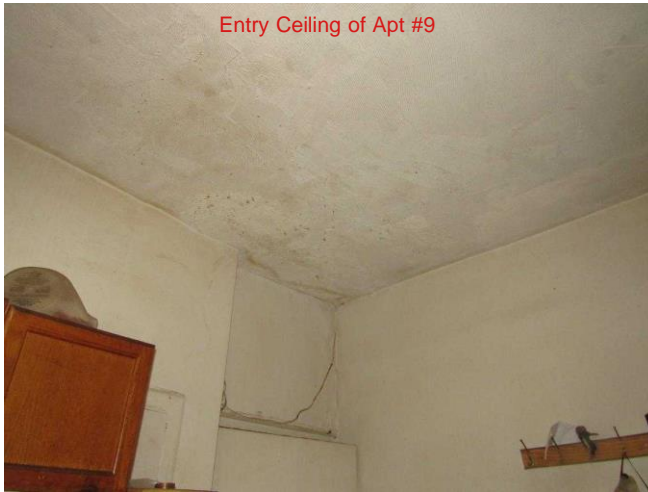
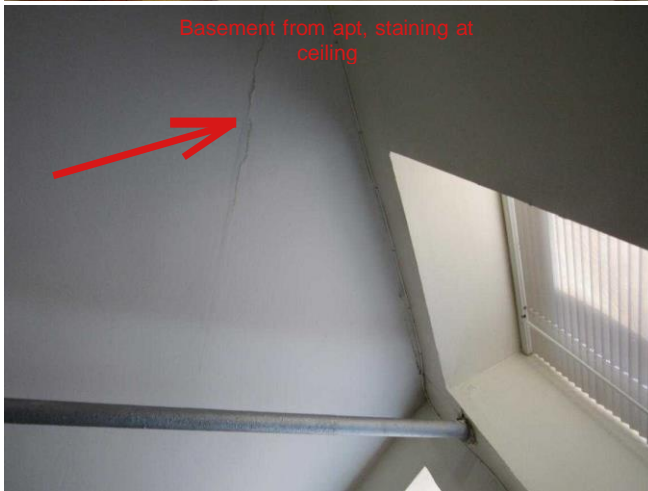
Damaged portions of ceiling due from water was noted at Apartment #9. The areas should be repaired by a reputable contractor.

Staining noted at front basement apartment ceiling - repairs are recommended.

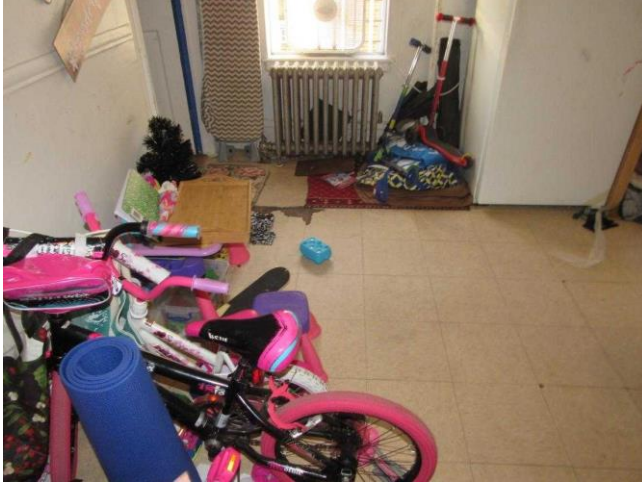
Minor Floor: Due to stored items on the I was unable to determine the condition of the portions of the floor that were not visible. Cracking of many of the apartment flooring noted and settling of Apt \$9 entry floor. Repairs are recommended.

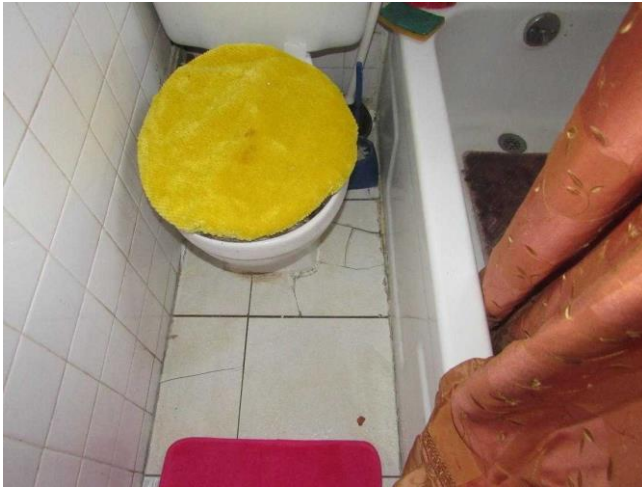
Attention Needed Floor: Ceramic / vinyl tile — Apt#4

Cracked flooring noted - replace damage portions.

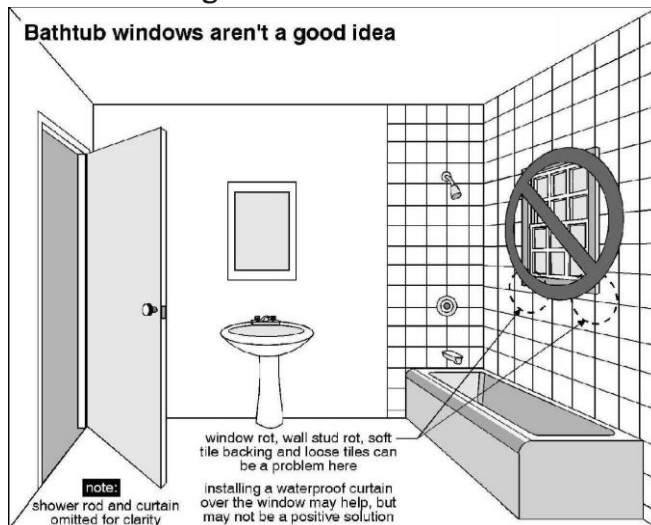
Windows: The window is in a moisture / wet location. Replacement to vinyl window frame and window covering is recommended.

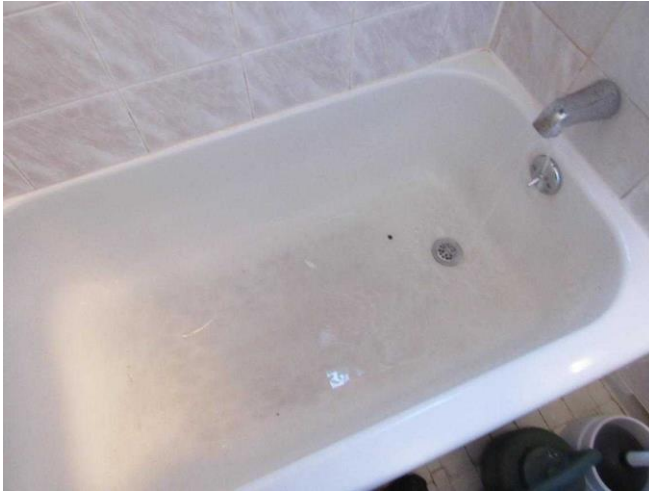
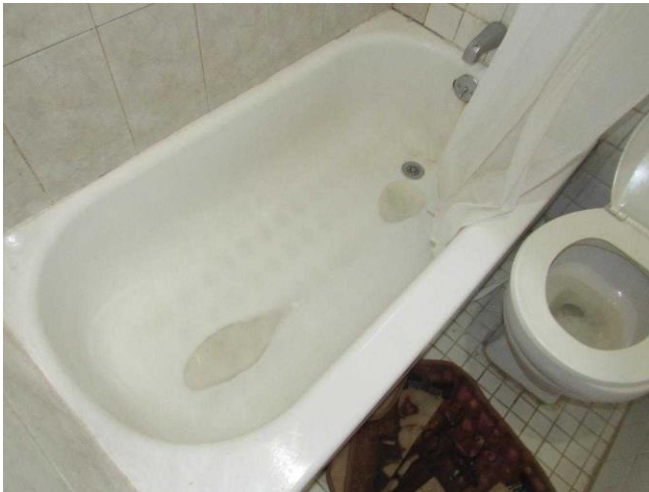
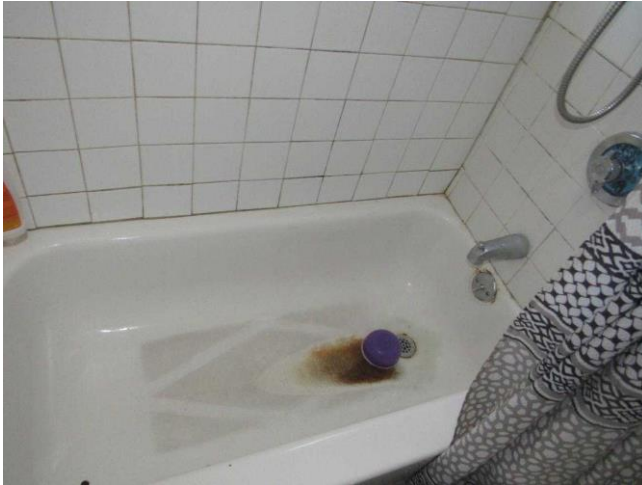
Attention Needed Tub/Surround: Fiberglass tub and ceramic tile surround —

There was damage to the surface of many of the tubs. It is recommended to "refinish" the bathtub a process of restoring worn, impossible to clean, chipped or dated color bathtubs to look and feel like new

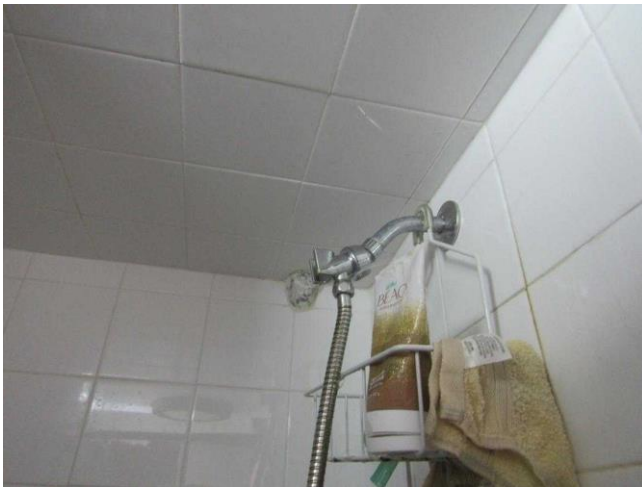
Shower/Surround:

Leakage at knobs of APT #5 - Repairs are recommended.

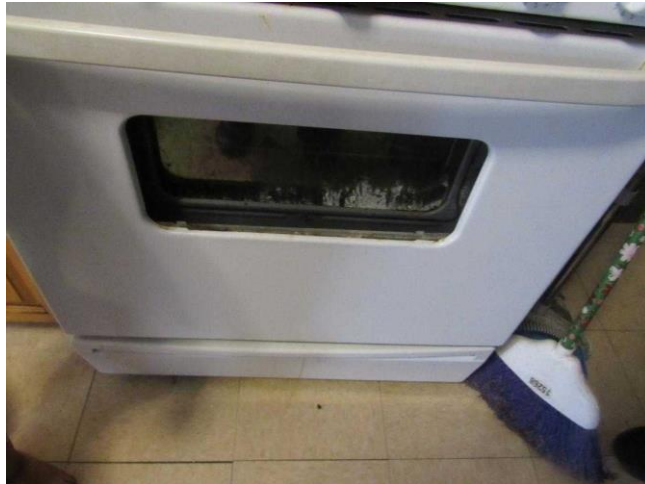
Apt # 3 oven was inoperable - glass for door was broken. New oven should be installed.
