Property Inspection Report

Inspection Date: 08/23/2022

Building Type: Warehouse , commercial Garage:

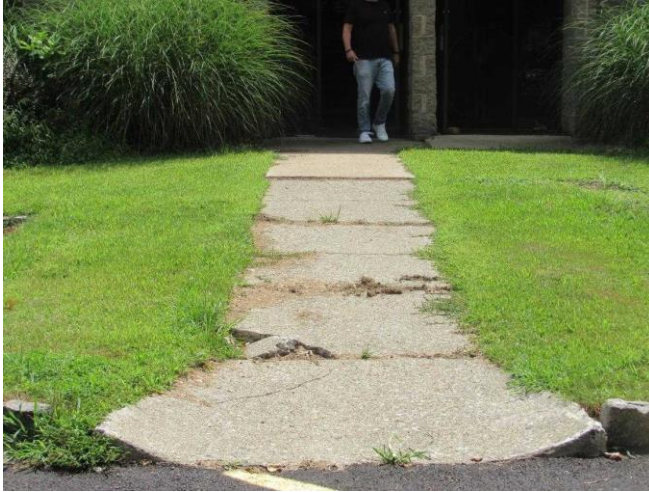
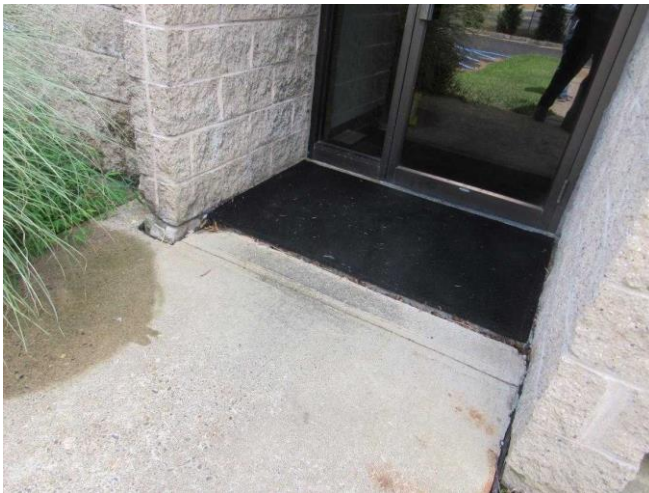
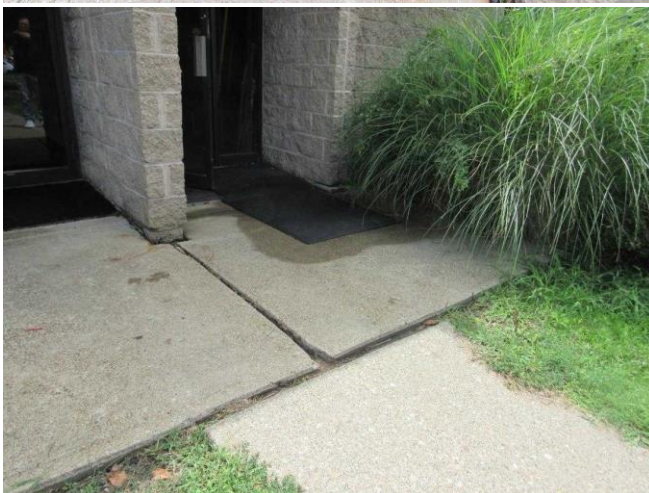
Concrete pitted and chipped, Walkway was protruding / not leveled. The current condition presents a safety hazard as one can trip and get hurt. The walkway should be repaired prior to closing.

Rear left entry had a step up from walkway to entry greater than 9". The current condition presents a tripping hazard and should be repaired.

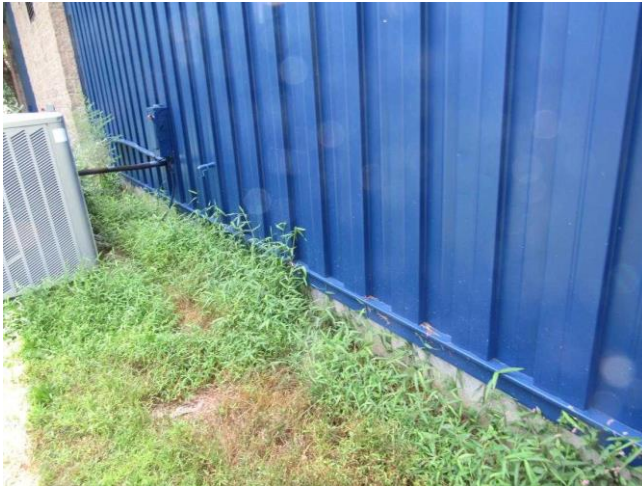
There was minimal shrubbery near the front of the structure. Shrubby near the structure prevent the siding from adequately drying. This condition may allow water penetration into the home and provide a conducive environment for wood destroying insects.

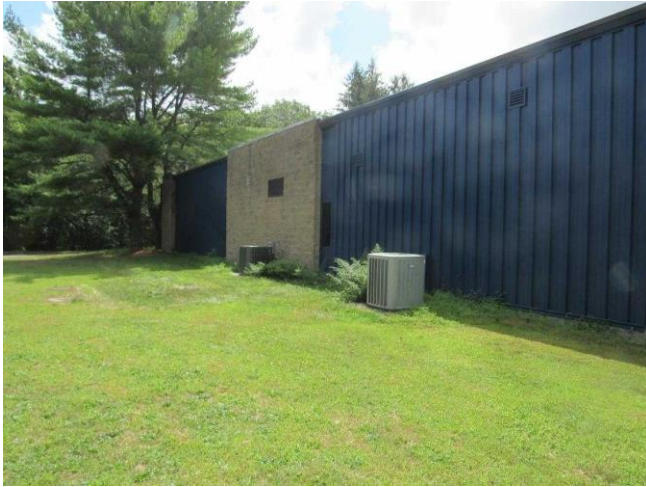
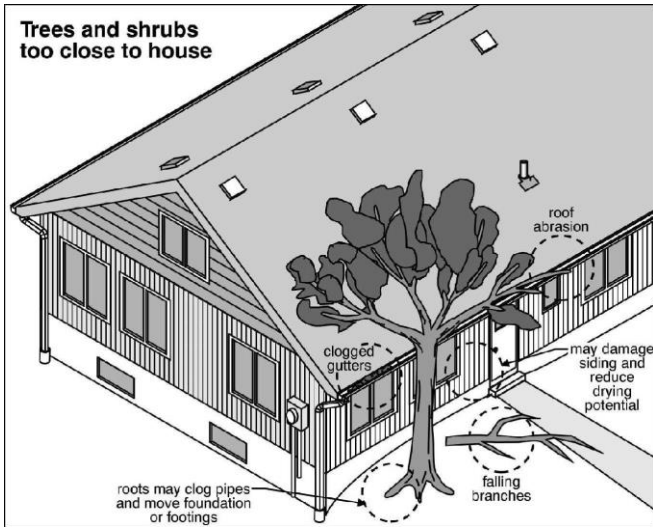
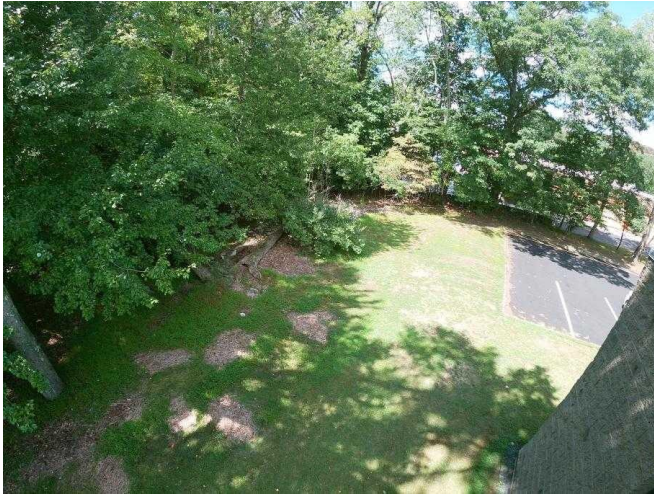
Tree limbs over hang the left side and should be cut back. Tree limbs overhanging the roof will damage the structure, prevent the roof from drying - decreasing its life expectancy, and provide easy access for pests and animals into the home.

There was dead tree leaning on portions of other trees at rear right side that should be removed.

Determining conditions of trees is beyond the scope of this inspection. An evaluation by a qualified arborist is recommended to estimate services required to repair this problem.

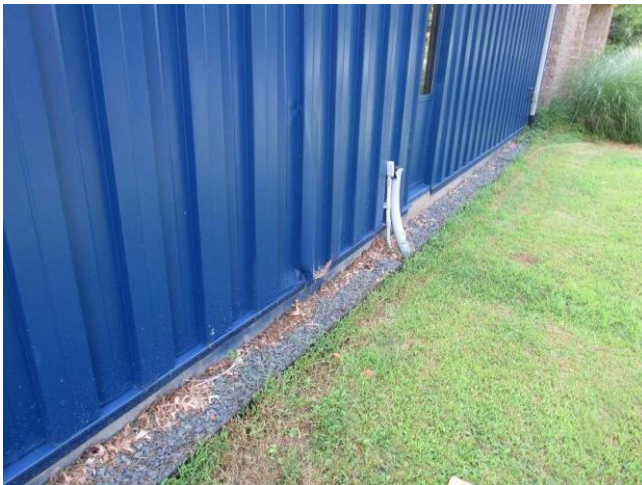
Type: Aluminum siding, Brick veneer — Portions of metal siding was dented.

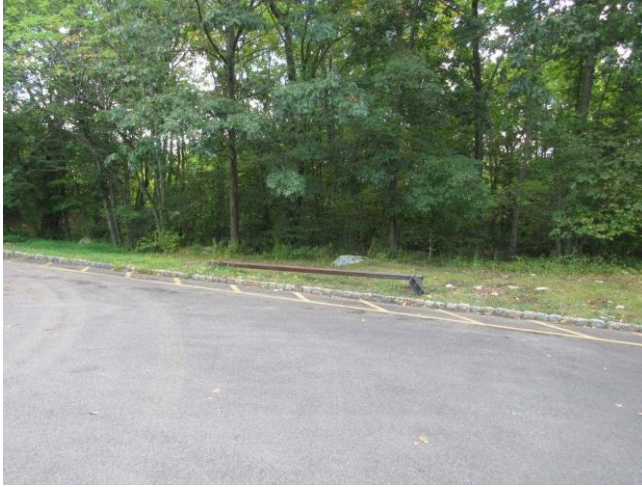
The pole fixture at left rear was down on ground. Repairs are recommended.

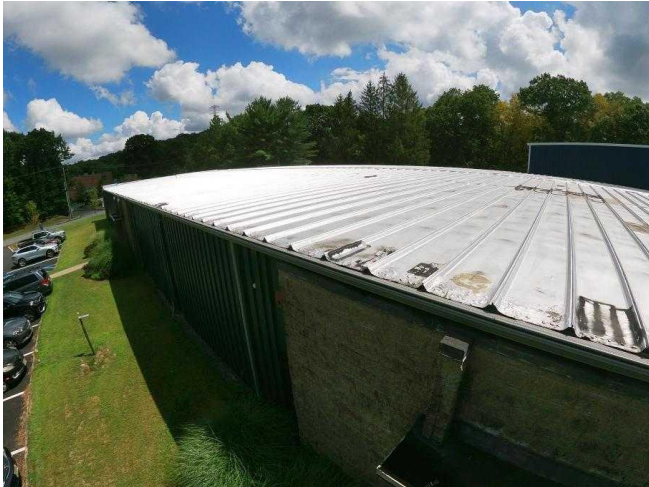
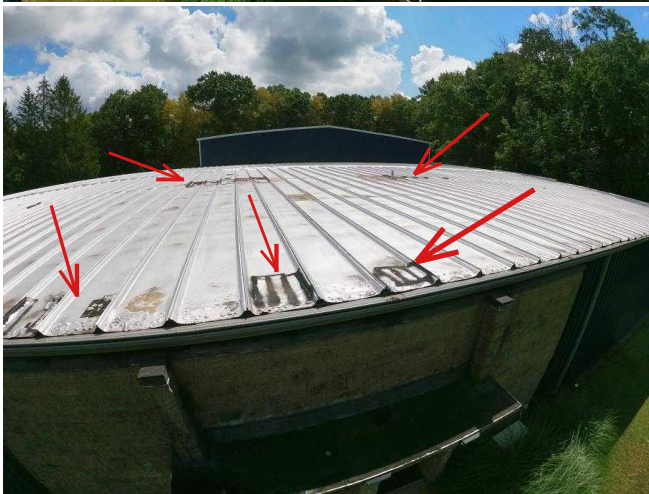
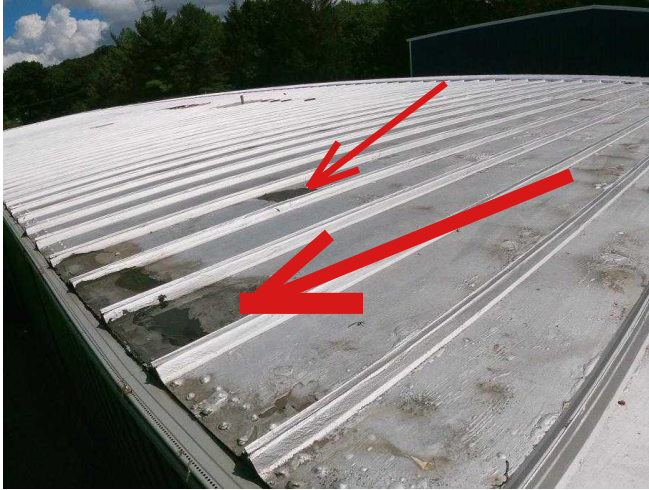
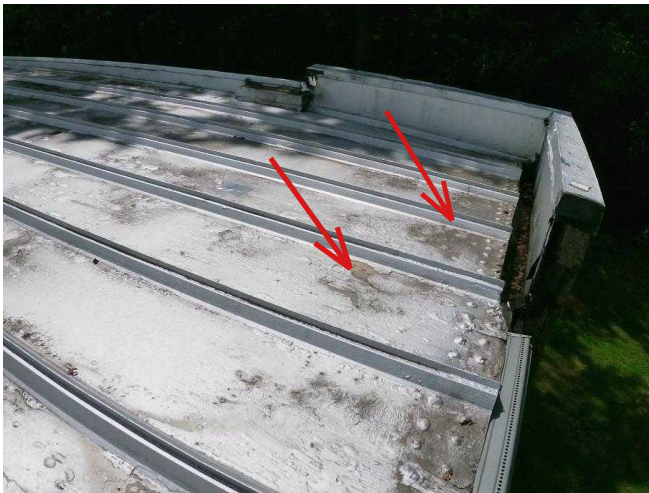
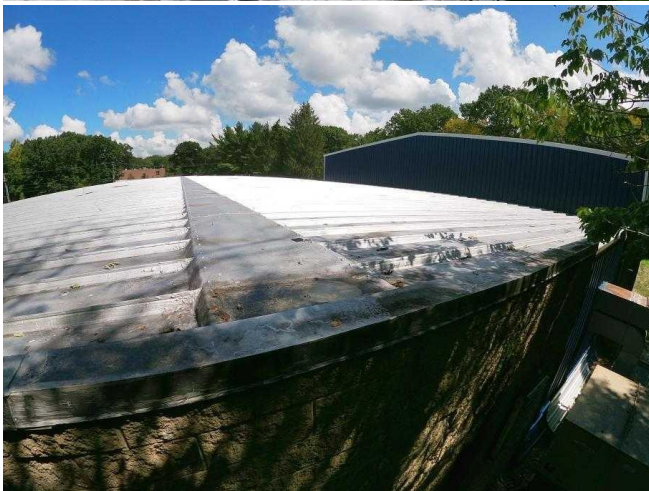
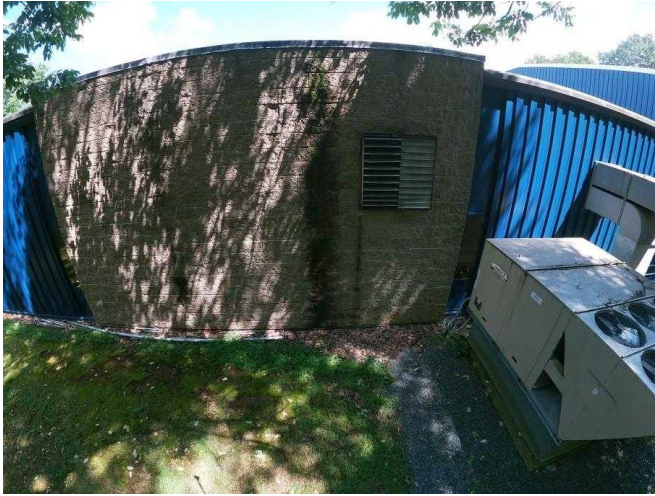
Patched portions of roof coverings were noted at various portions of the roof at main structure roof. Patching is a temporary fix which is prone to further leakage.

Portions of the applied grey acrylic type paint on the roof has pealed. This conditon will cause rust for the roof fasteners and may allow for water entry.

Rear right portions of roof had excessive staining. There was also excessive staining on the brick veneer siding. There appears to be inadequate drainage at this area. Repairs by a reputable roofer is advisable.

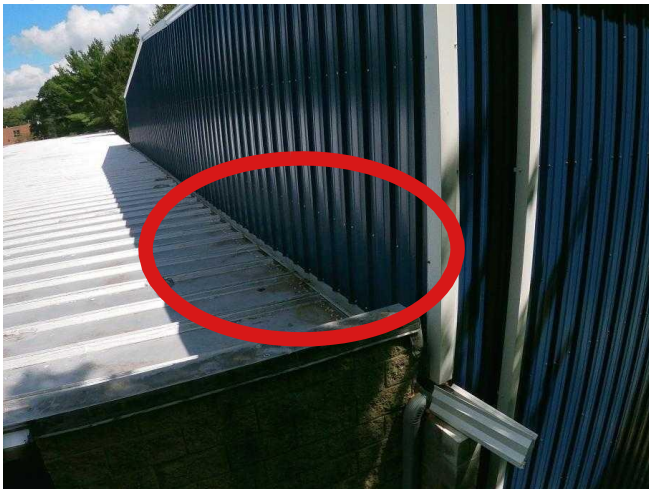
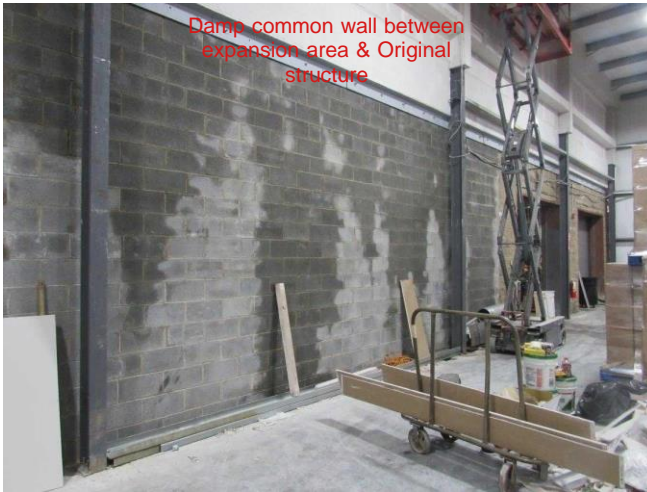
There was dampness at the fire wall between the older and expansion area of the structure. There was some rust stains noted at the flashing area. Services of a reputable roofer is recommended to repair area.

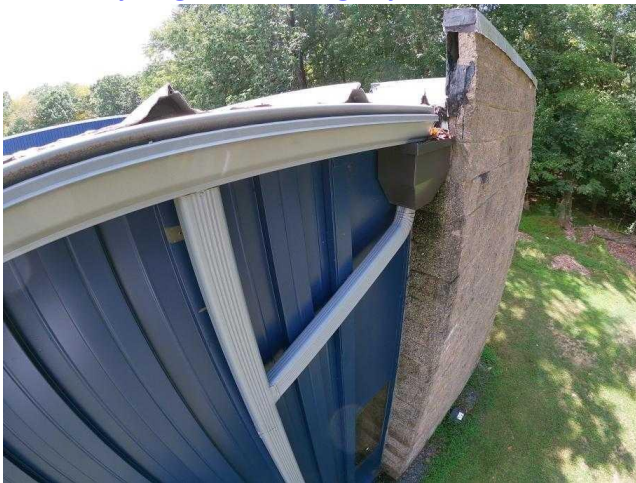
Excessive debris and minimal leakage was noted in the right rear gutter. The gutters need cleaning and repair to fully function.

The entry way lower roof did not have gutters installed. This condition allows water to accumulate near entry. A gutter drainage system should be installed.

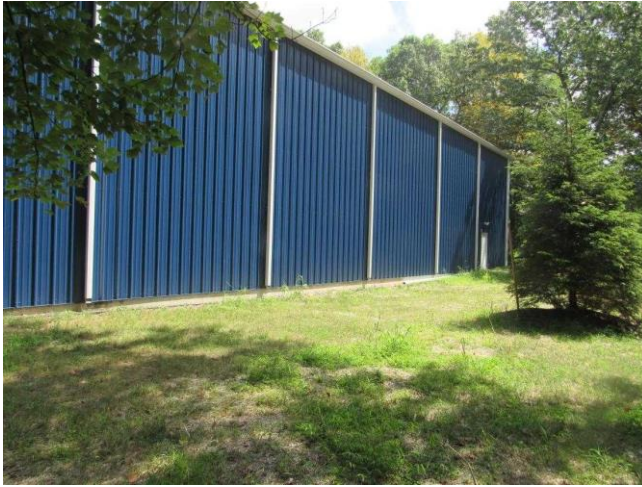
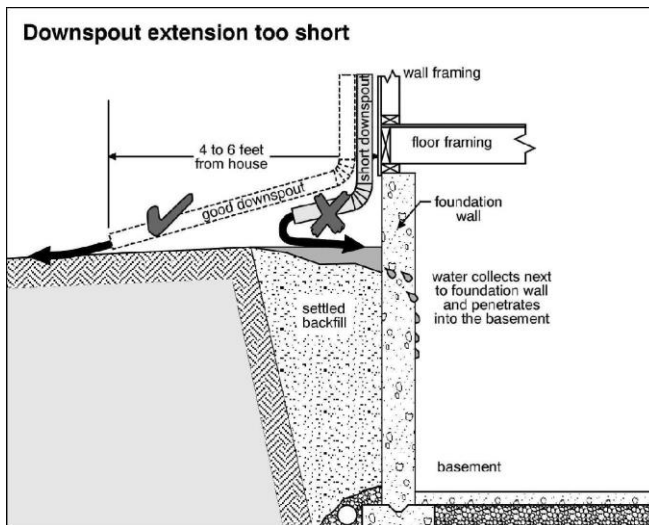
Portions of the downspouts, at expansion area drain near the building. Continuous ponding of water near the building will affect the structure and allow water entry into the structure causing mold growth.

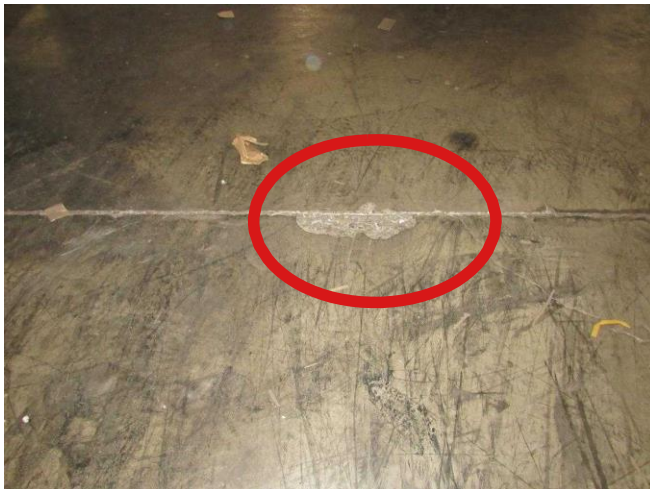
- Monitor Structure Type: Metal frame — Portions of the studs had some rust. No action needed at this time, monitor area and repair as needed.
- Acceptable Foundation: Poured
- Acceptable Beams: Steel I-Beam
- Acceptable WDI This inspection and inspection service is not to be held liable for any representation as to the evidence of or lack of evidence of any wood destroying insects. This was only a visible inspection of the readily available areas of the basement level, and no areas covered by any materials such as wallboard, insulation, furniture, or stored items were included.
- Acceptable Joists/Trusses: Steel joist trusses
- Acceptable Piers/Posts: Steel posts
- Attention Needed Floor/Slab: Poured slab —
 Cracking noted on portions of rear warehouse flooring and presents a safety hazard - repairs are recommended.

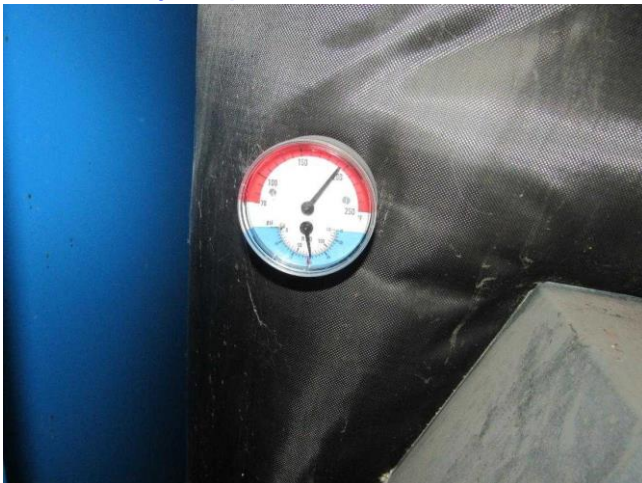
The Front Boiler room does not have a fire rated door or/and ceiling. There was exposed fiber glass insulation. Fire rated materials may slow the spread of fire to the rest of the home. Current safety standards require fire rated materials in boiler /furnace room. Repairs recommended.

The PSI for the rear Buderus unit was above the gauge threshold and may cause leakage. Further evaluation by a reputable HVAC contractor is recommended.

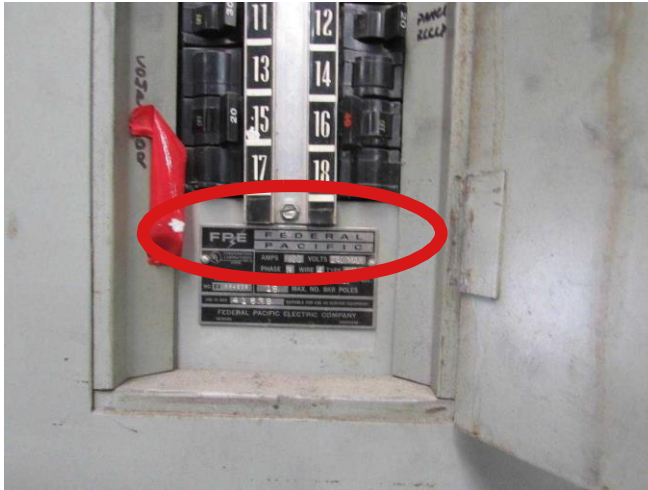
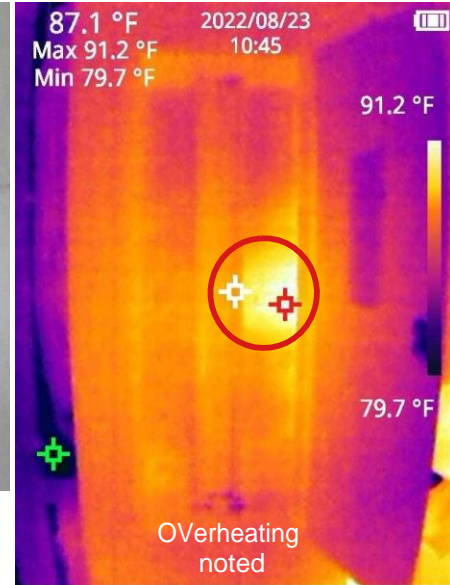
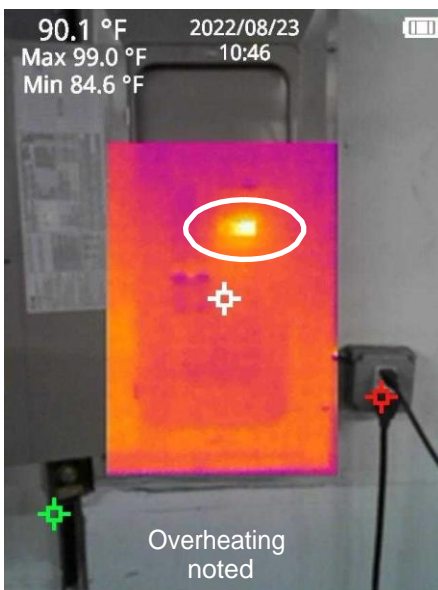
Action Needed Manufacturer: Federal Pacific, Murray, I-T-E —
Federal Pacific panel breakers have a history of not tripping when circuit overloading exists. The panel should be replaced prior to closing., ,

The electrical panel was tested for overheating. A Portion(s) of the breakers at larger panels adjacent to expansion warehouse areas were hotter than other breakers. This condition is indicative that several of the breakers are overheating. Further evaluation by a reputable licensed electrician is needed.

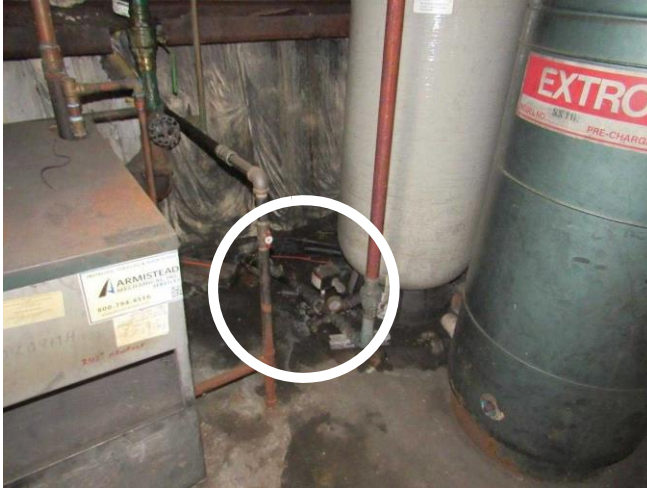
Leaking, A licensed plumber is recommended to evaluate and estimate repairs

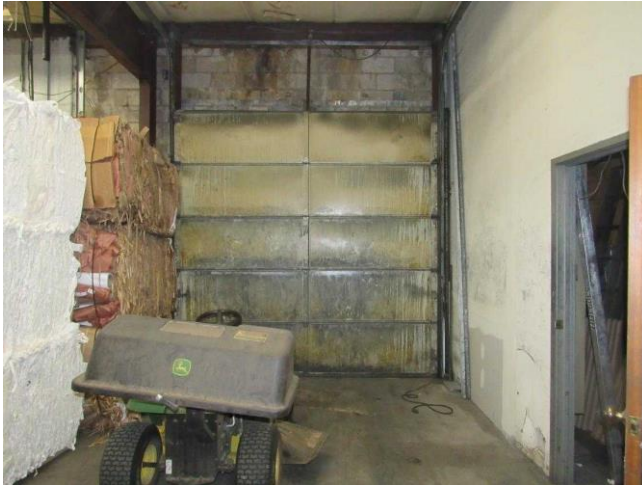
The left front overhead door had - Broken springs, The overhead door slams shut. The lift for truck platform was operated manually. Repairs are recommended.
